Objet : Demande d'accès à l'information

Site Characterization Report

Abandoned Mine sites

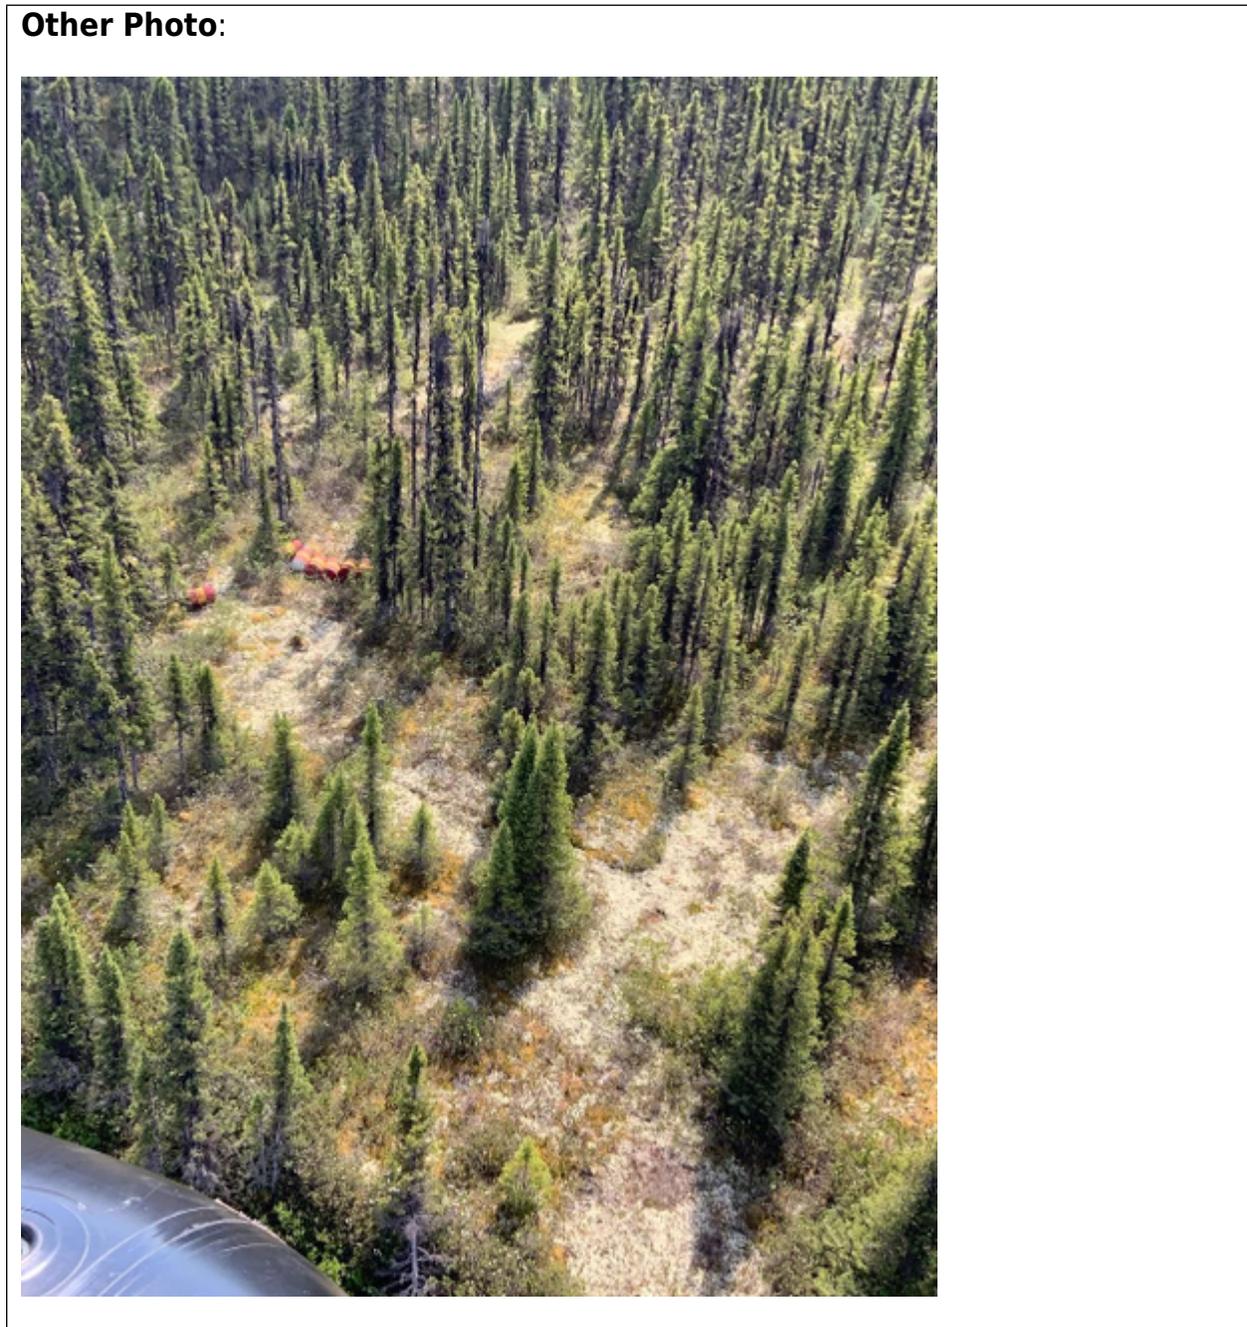
| Other Information : Couldn't land but tally man confirmed he recently inspected and drums were full. Can easily be cleaned once landing pad is made. | |

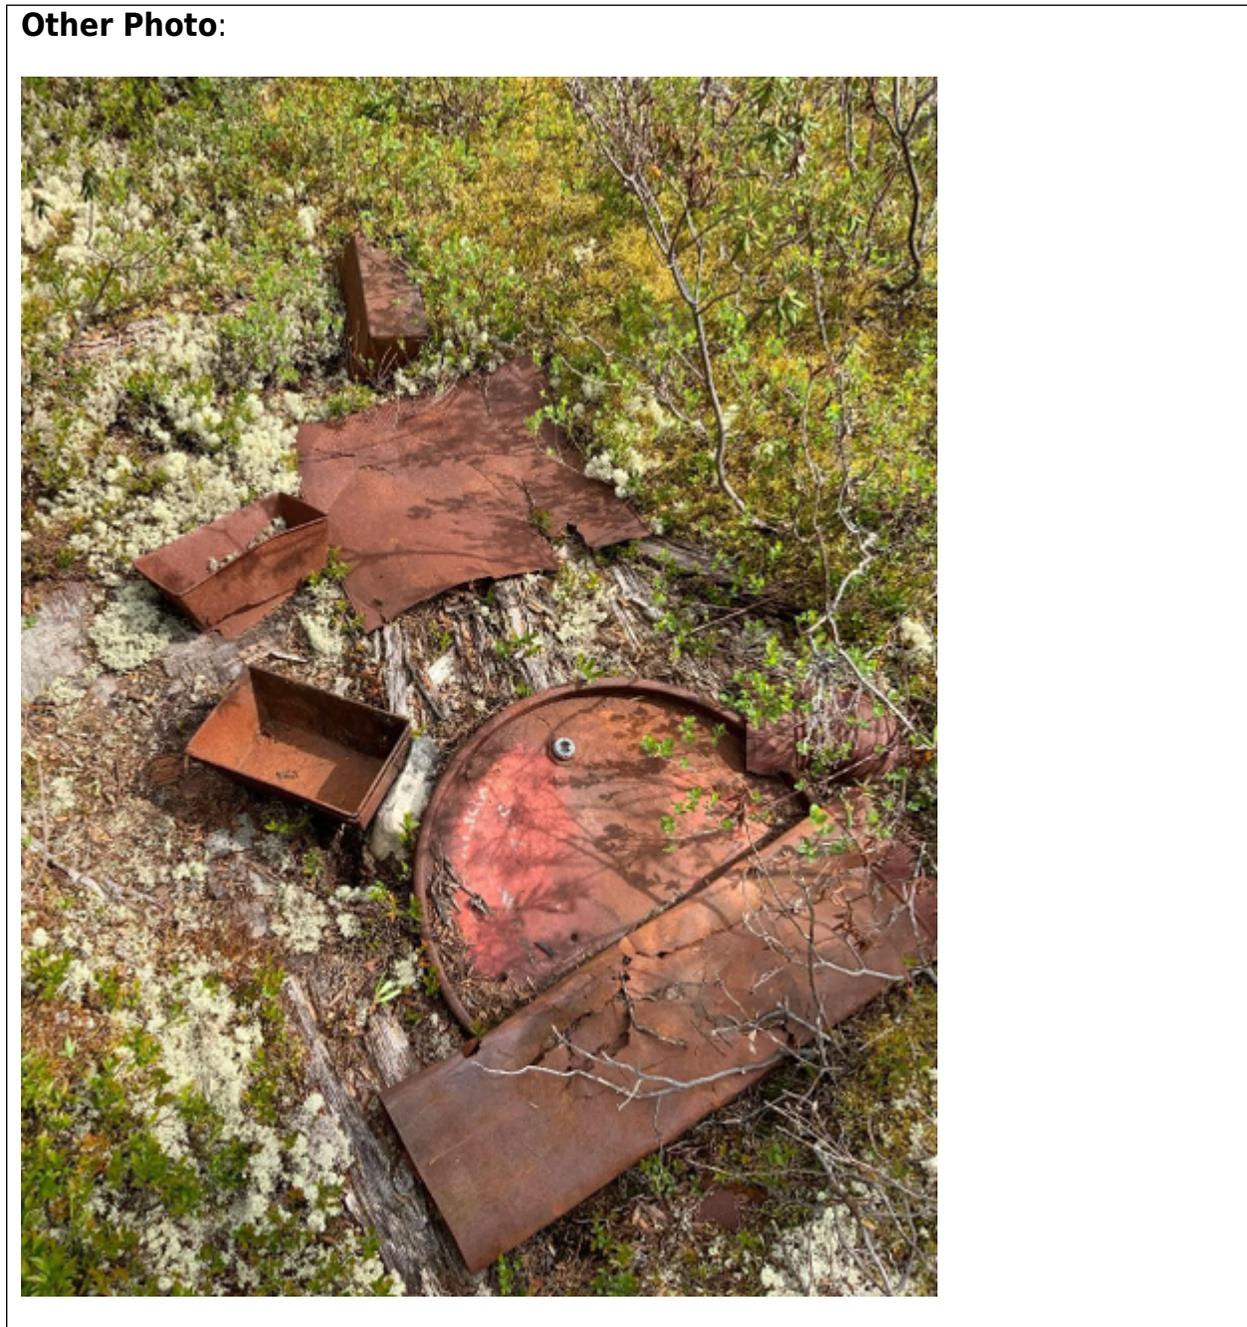
| Other Information : Camp reclaimed by nature, old stove pipes and other metal pieces. Very rusty. Helicopter can land on the point. Could be cleaned in 1 day by sling with 2 workers .s\ | |

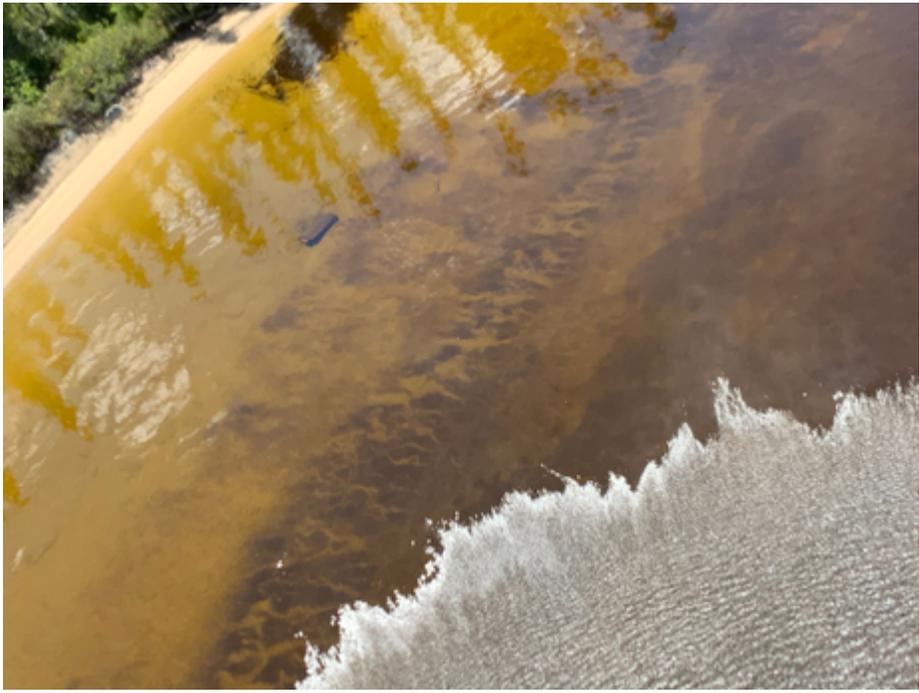
| Other Information : Couldn't land, to many trees . Need to cut a pad or go by float plane . Need to go back to check if drums are empty | |

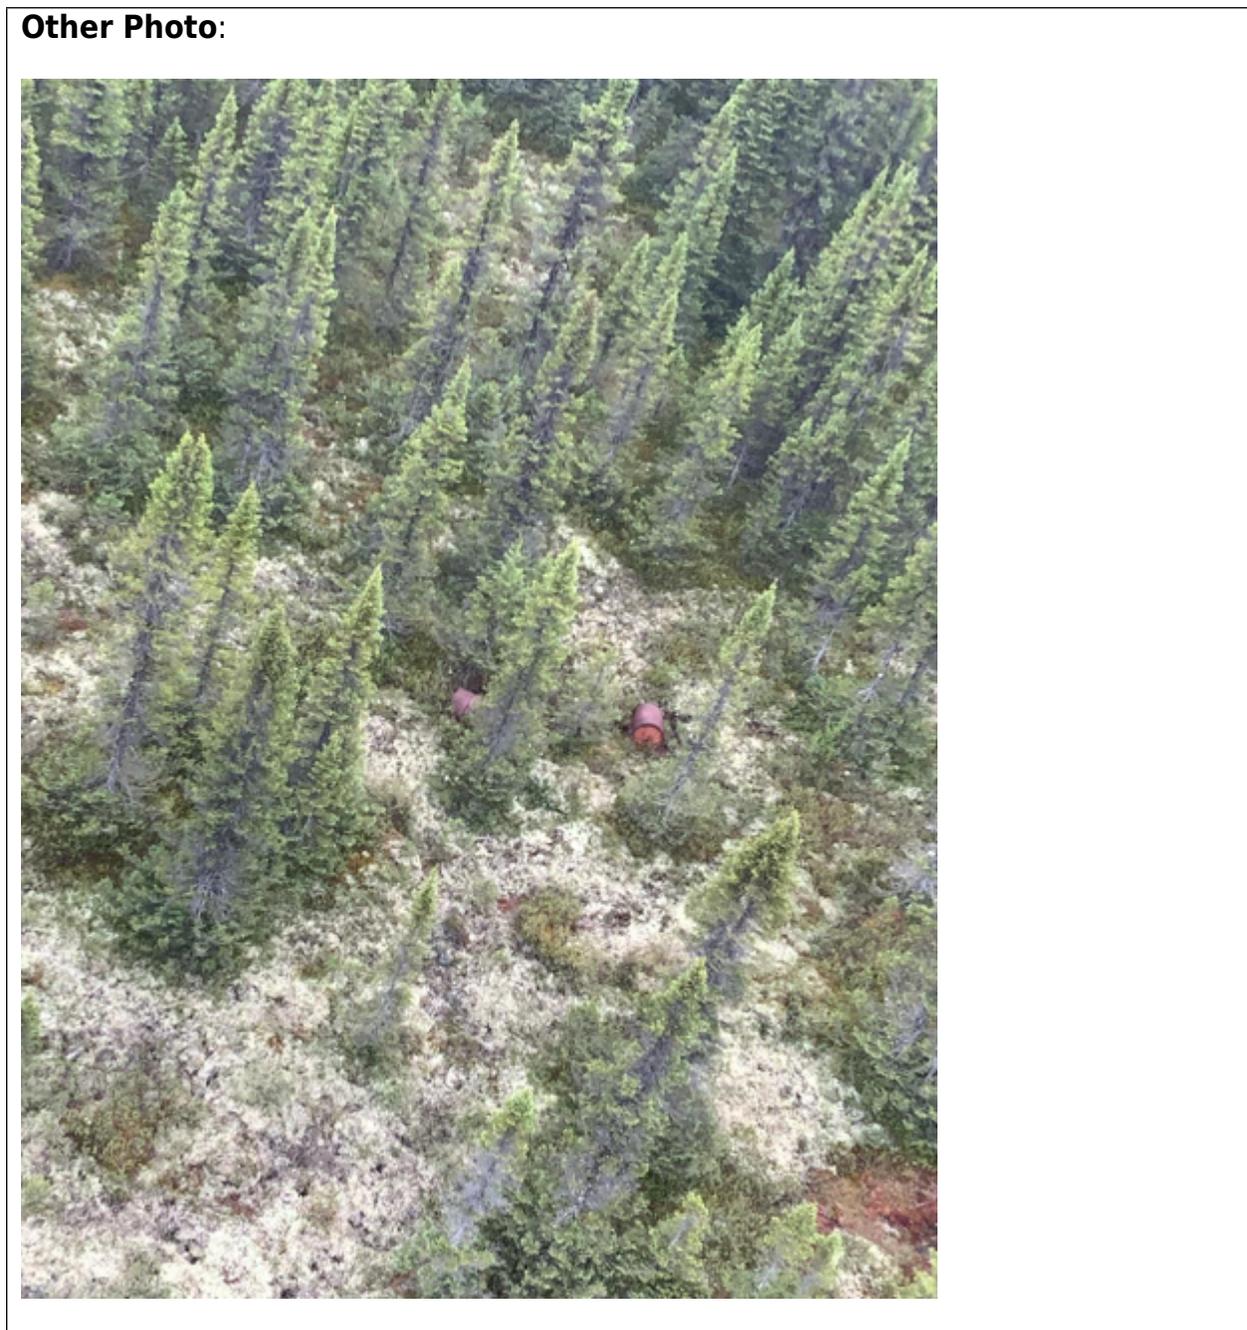
| Other Information : 2 old drums on site , unsafe to land , took pictures. Tall man says drums are empty | |

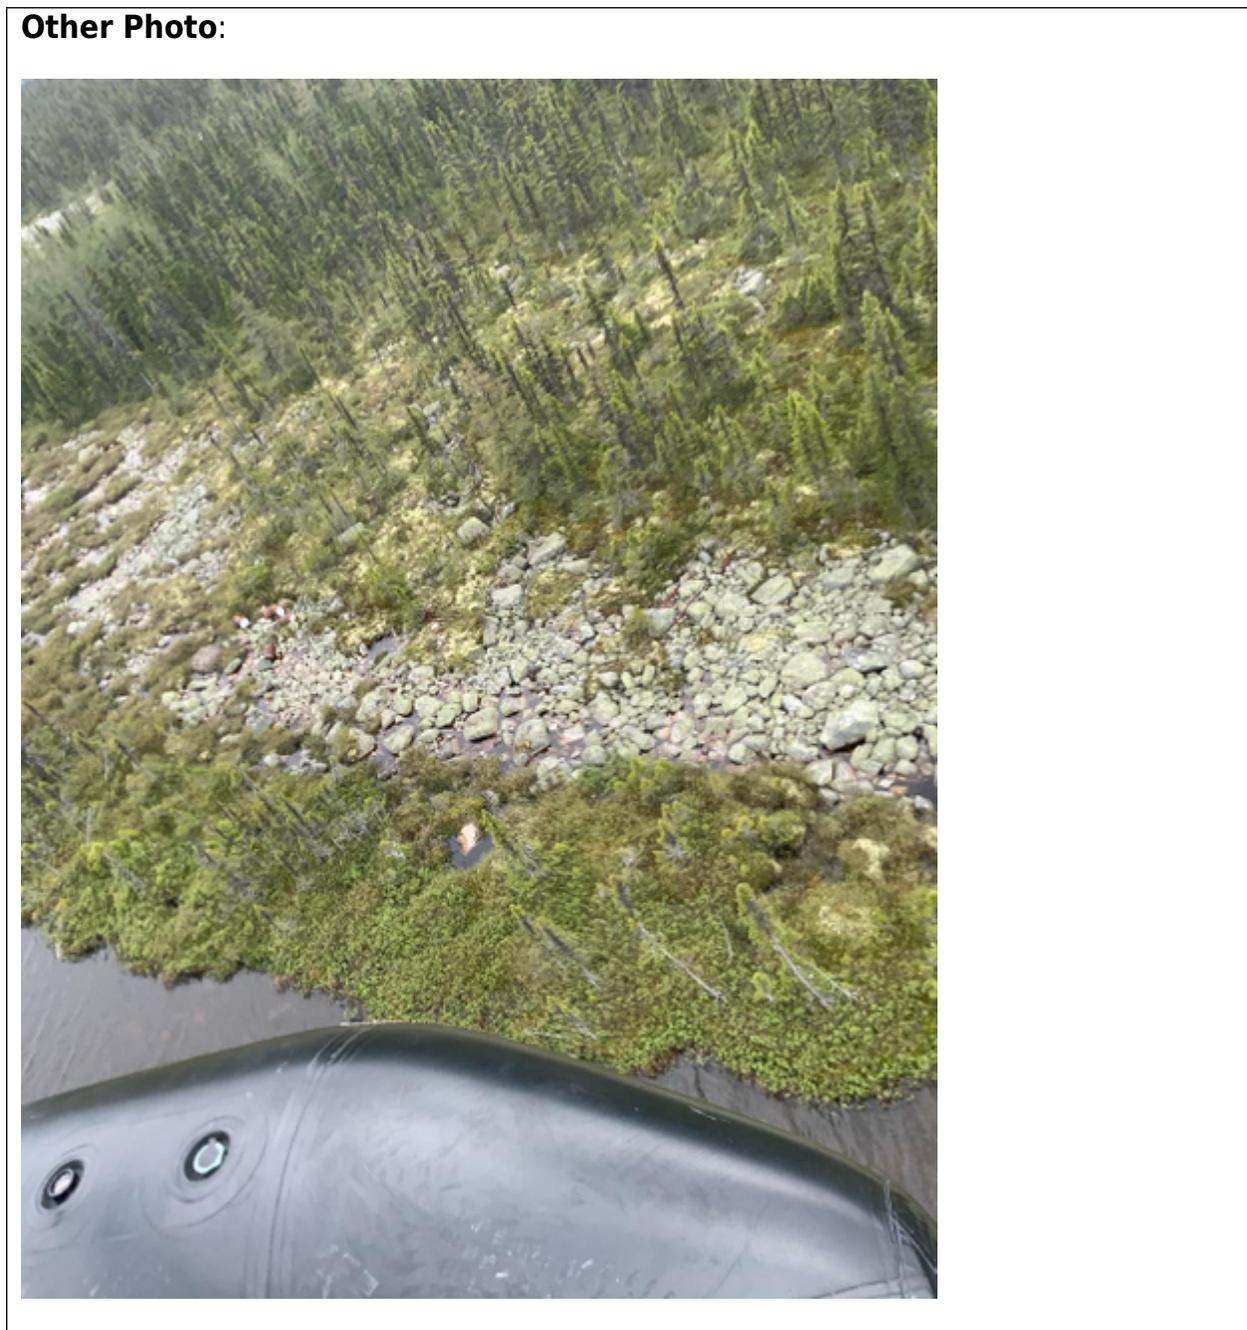
| Other Information : 5 drums in one spot in fair condition. 3 other drums spread out along shore. | |

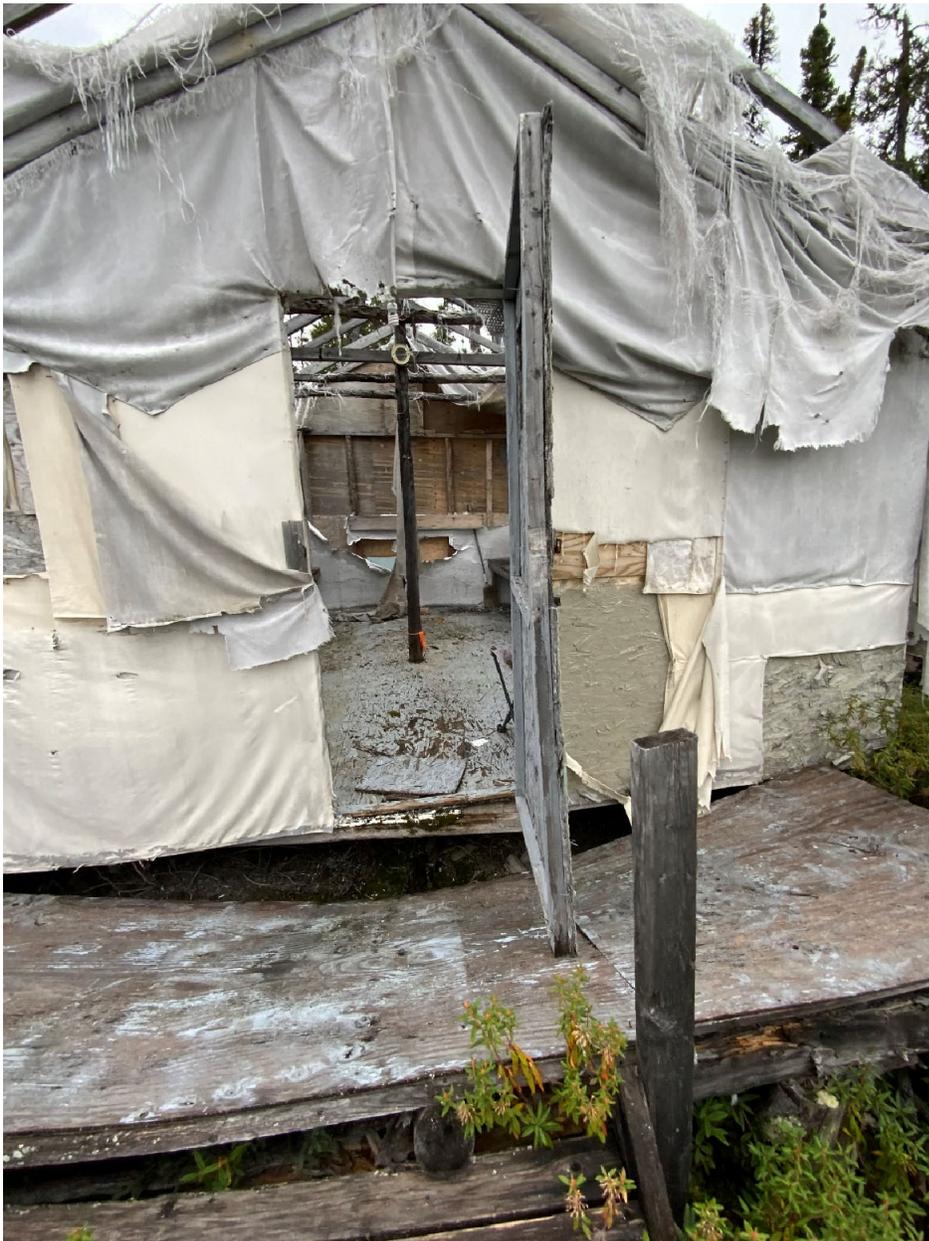
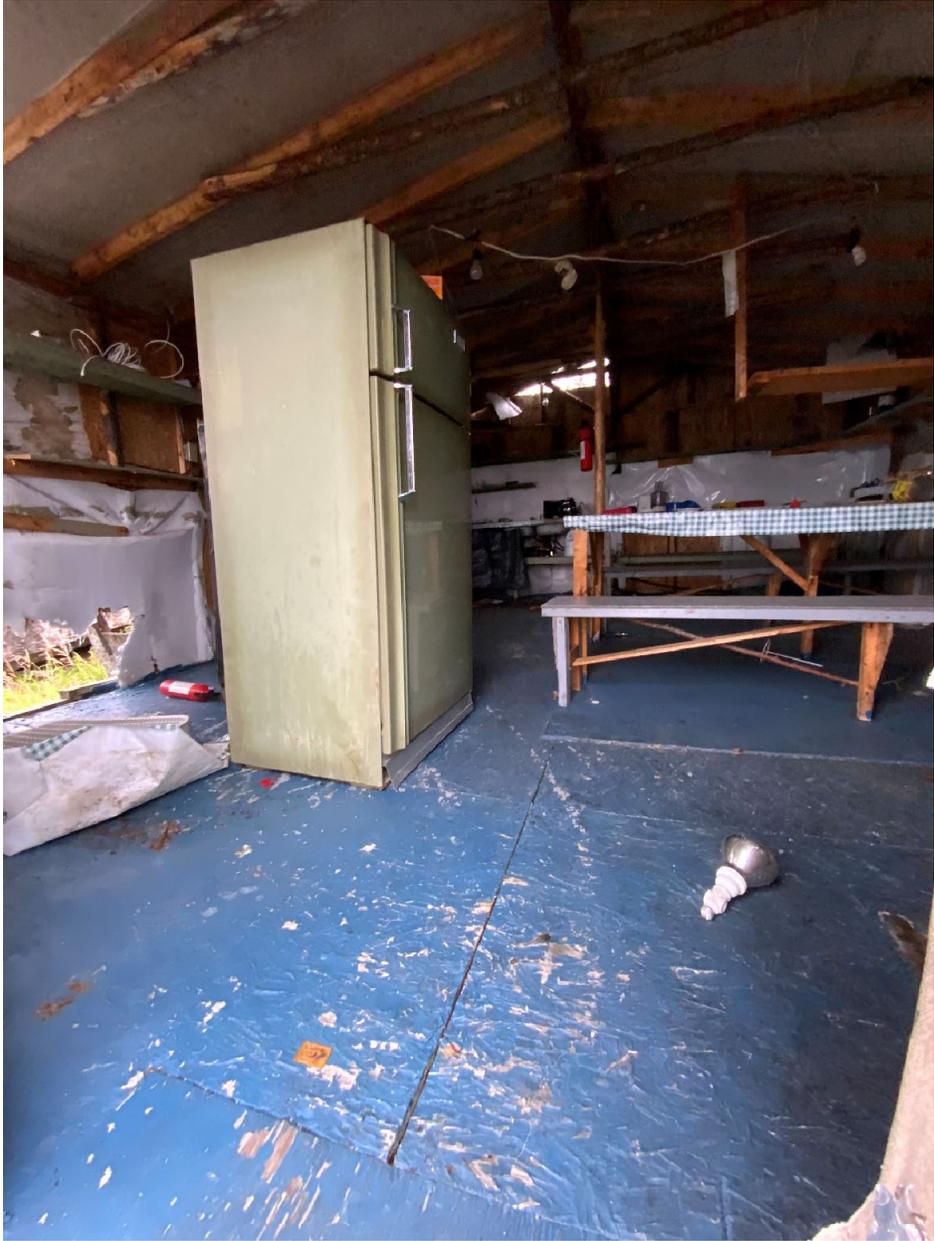
MI/21-326

1 fridge , 1 hot water tank,1 washing machine,1 water pump. Belonged to a company named Dios about 16 years ago according to tallyman.
