# Full-scale Mass Timber Shaft Demonstration Fire – Final Report

**Date:** April 8, 2015

## **PROJECT N<sup>o</sup>: 301009899**

### **NRC Report: Fire Demonstration Cross-Laminated Timber Stair/Elevator Shaft**

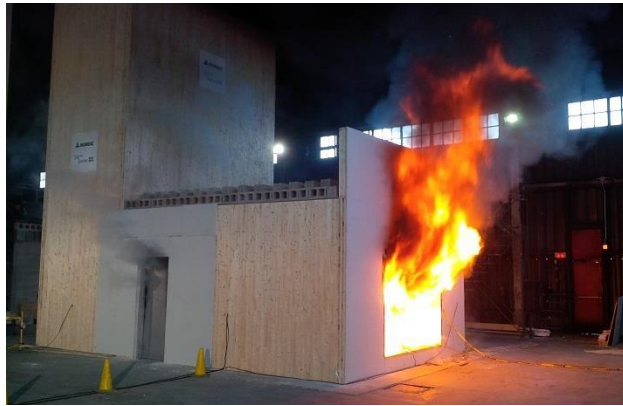
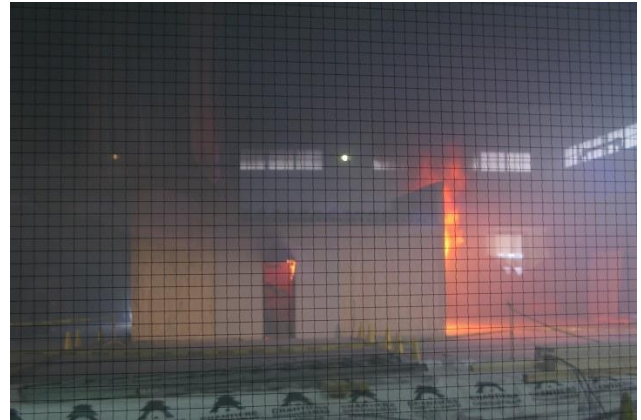
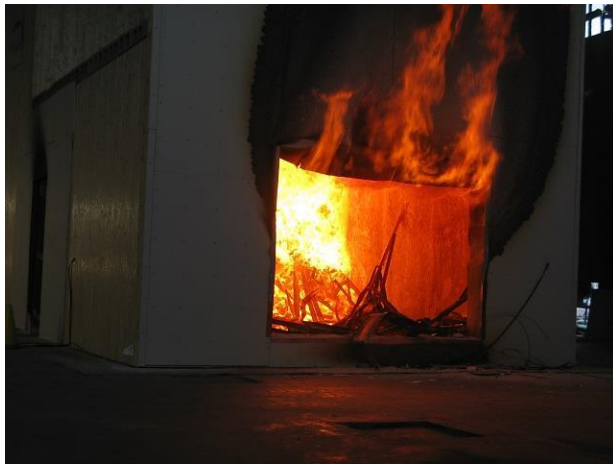
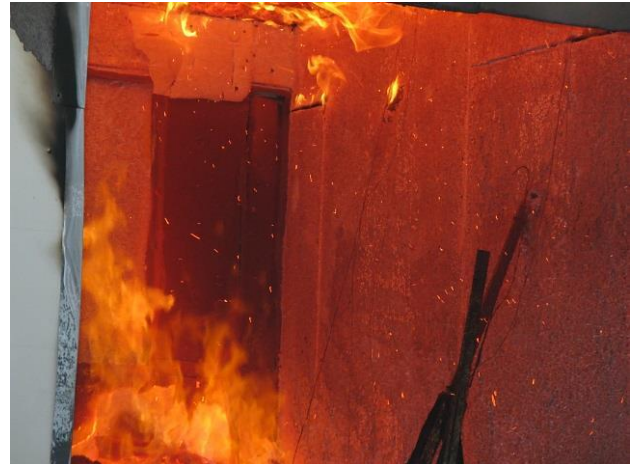
**Figure 9. Demonstration fire**

The fire was initiated on a loveseat and quickly reached flashover within the first few minutes. A detailed account of the observations can be found in Table 1. Flames are seen protruding out the window early in the fire in Figure 9 a). At this point, smoke was observed around the 45-min fire door frame, which subsided after several minutes. After ten minutes some light flaming near the door handle was seen, likely related to some combustible material in the handle or door mechanism.

Forty (40) minutes into the demonstration the fire visually appeared to be decreasing in intensity, which resulted in greater visibility into the room. This decrease was also noted in NRC's Client Report, and was attributed to the surface of the CLT panels being charred which slowed the burning of the panels [3]. As the fire decreased, the back wall became observable and it was apparent that the first layer of gypsum board had mostly fallen off and the Roxul insulation and steel studs were still in place (see Figure 9 d)).

As the demonstration progressed, the first layer of CLT began to fall off the ceiling at 1 h. Once the first layer had fallen some more vigorous burning was noted at the ceiling as the second layer became exposed, however the overall fire continued to reduce in size [3]. Small pieces of the second layer were seen falling off at 1 h 40 min. The fire was permitted to burn for 2 hours, at which point the intent of the demonstration had been met and fire services were instructed to extinguish the remaining fire.

a) Approx. 5 min into demonstration

b) After 25 min

c) After 45 min, steel channels have fallen

d) &gt;1.5 h, some insulation and gypsum still in place

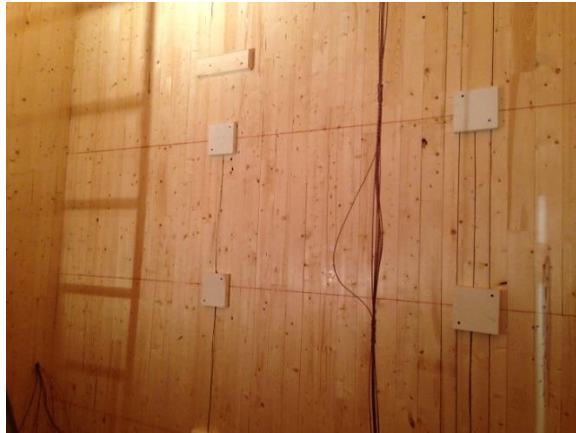
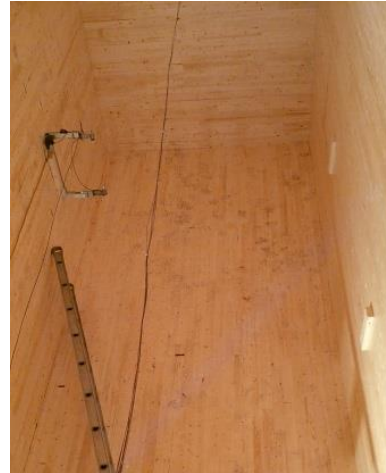
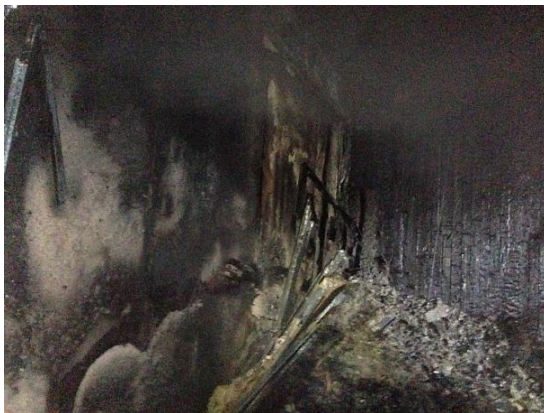
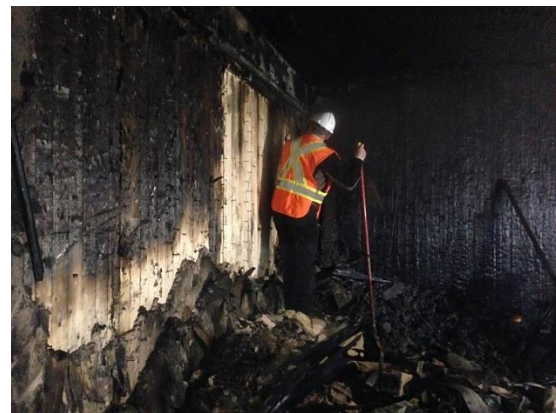
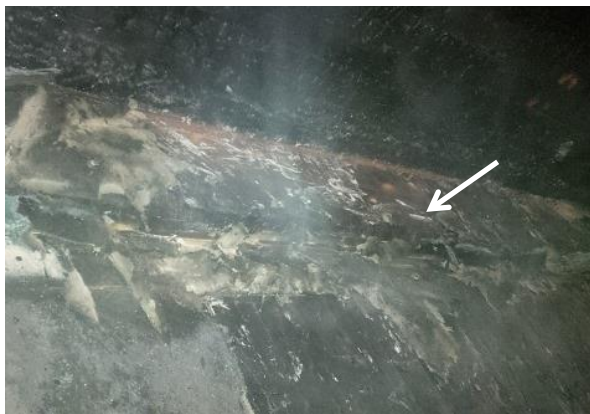
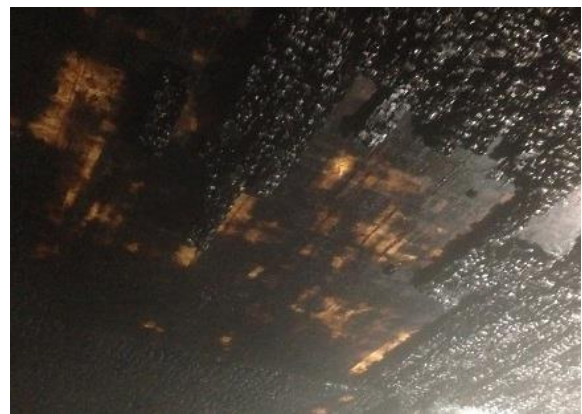
**Figure 10. Condition of the structure after the fire**

At the window the second layer of gypsum board was charred but still in place. Near the back of the room, by the fire door, the second layer was still in place but had fallen off in some places, exposing some of the uncharred third layer (see Figure 10 f). It is difficult to determine how much of the second layer fell off during the fire and how much fell as the fire was extinguished since fire hoses can exert strong forces.

**a) Interior wall of the shaft**

**b) Interior of the shaft**

**c) Interior of the fire room**

**d) View of the shaft wall from the fire room**

**e) Ledger beam in place and lightly charred**

**f) Ceiling assembly showing localized delamination**

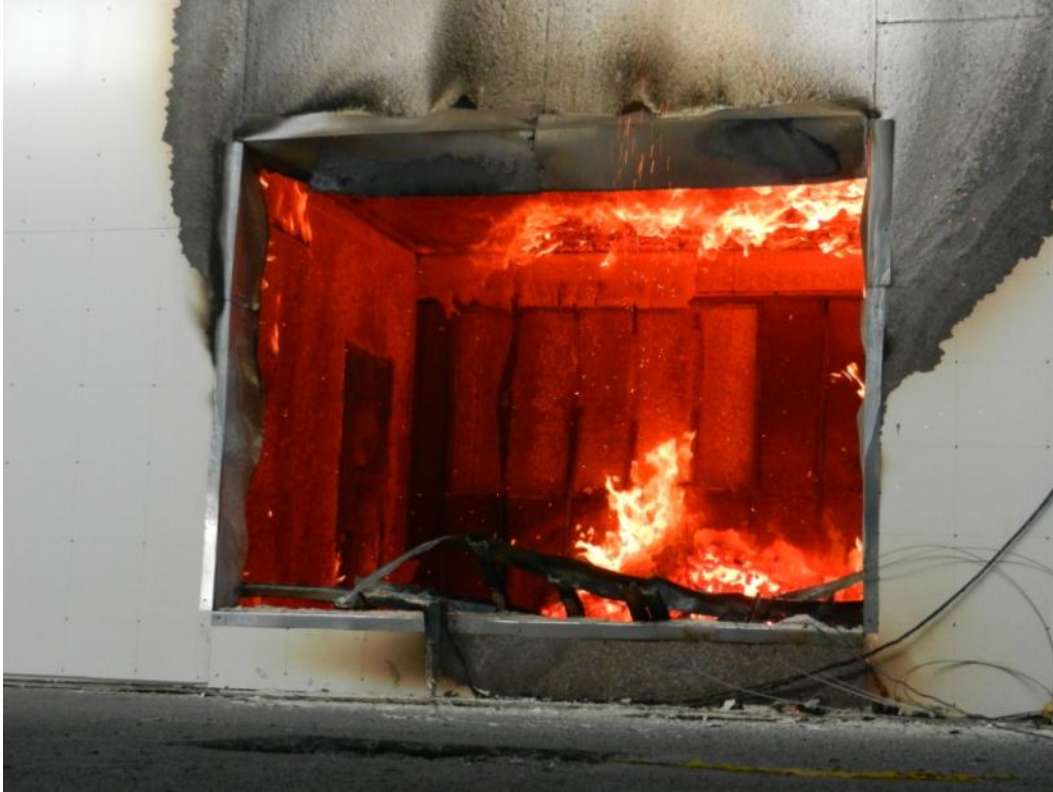
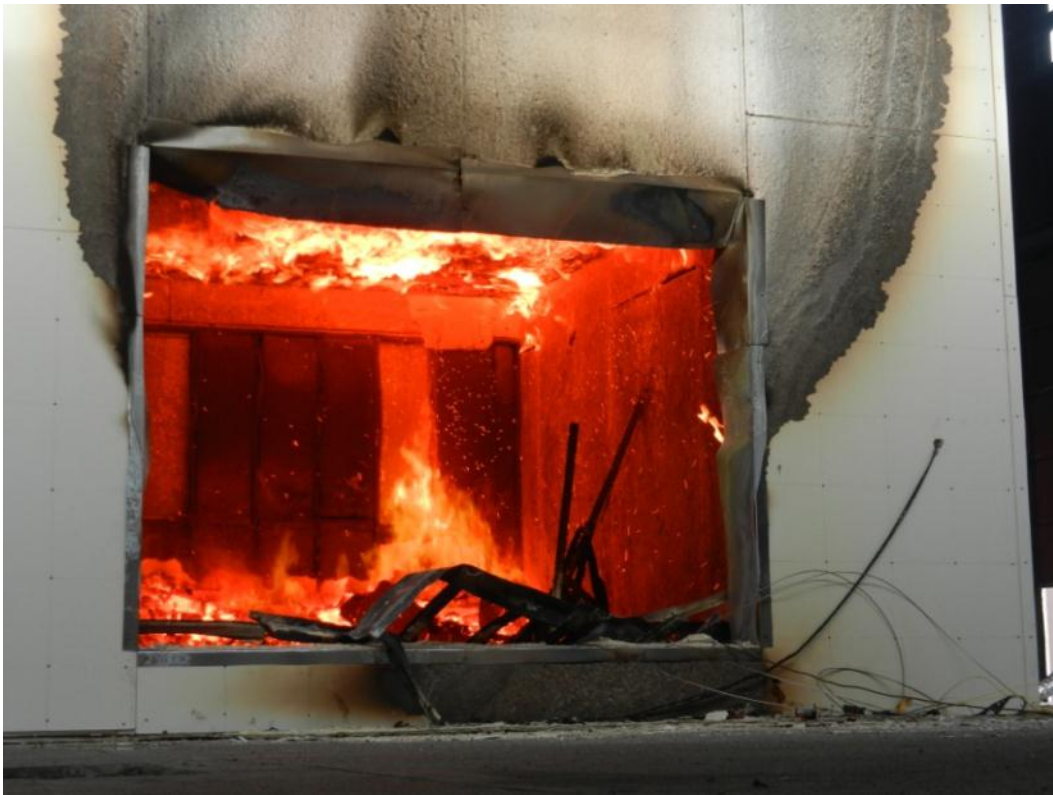
**Figure 28. Double layer of gypsum board and rigid mineral wool fibre insulation remained on the apartment wall until end of demonstration.**

The temperatures measured by the nine thermocouples located on the face layer of gypsum board behind the insulated steel stud wall show that the temperature rise value reached 270°C at a single point at 22.2 min, and the average temperature rise value for the nine thermocouples reached 250°C at 30.5 min. The insulated steel stud wall provided extra protection by at least these times for the CLT shaft panels. It was observed that the rigid mineral wool fibre insulation remained in place until the end of the demonstration (see Figure 28).

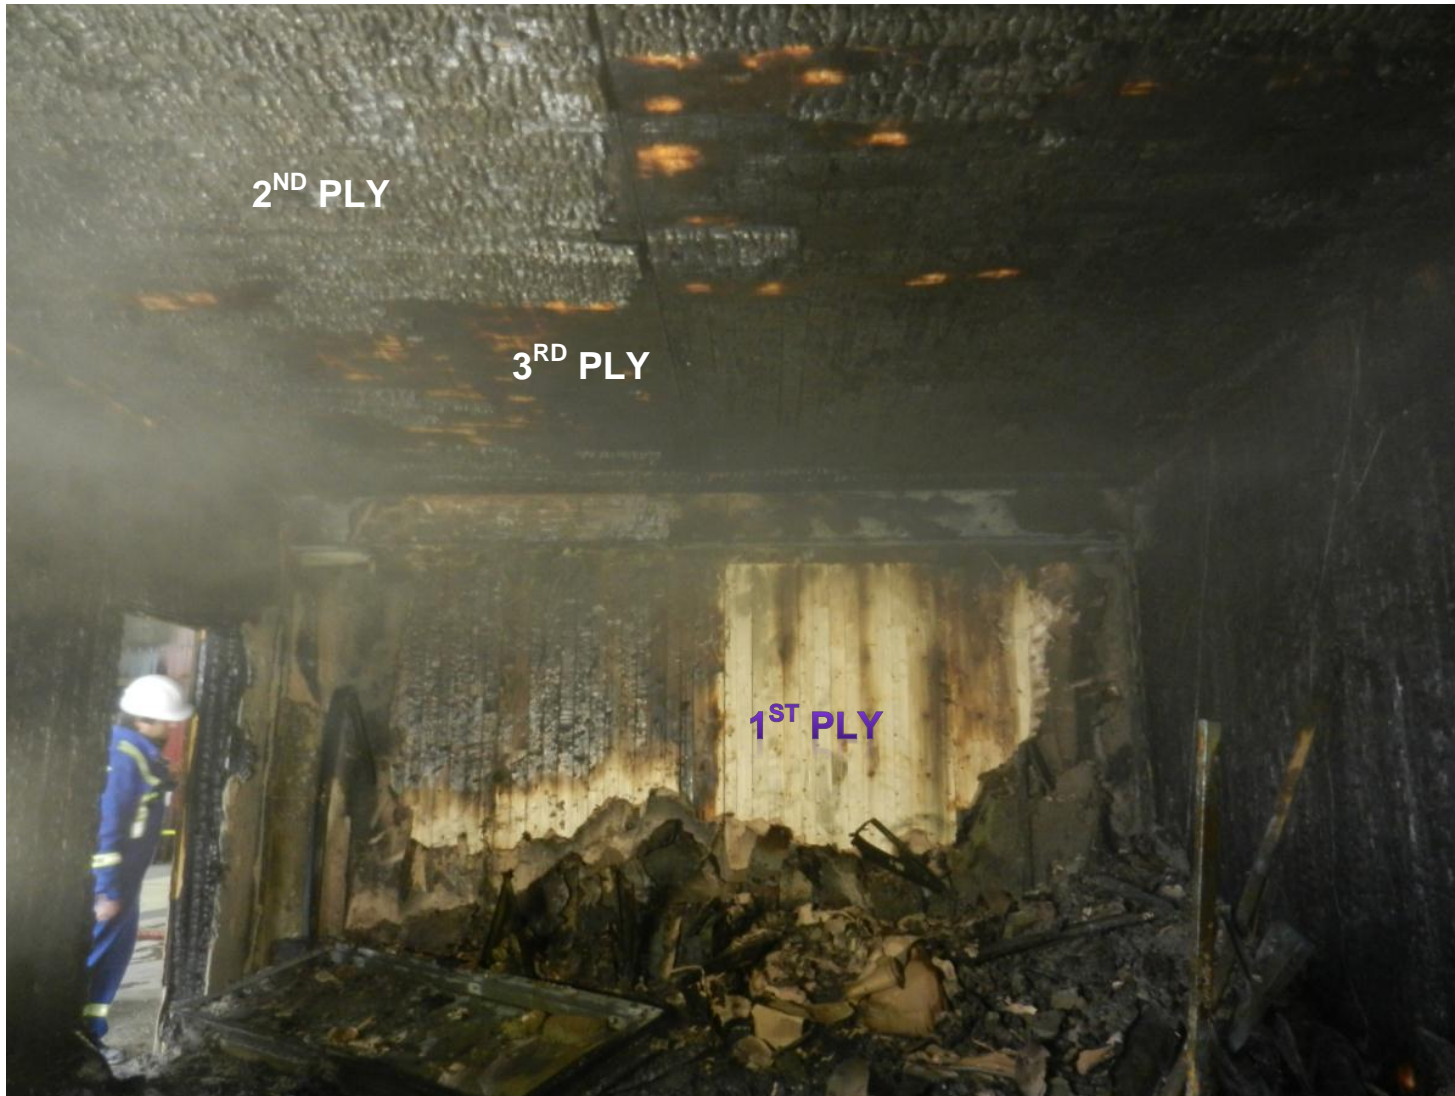
It was observed after the demonstration that two plies of the CLT ceiling panels were charred and consumed in the fire, but fell off after applying the water hose stream to extinguish the fire. The remaining plies of the CLT ceiling panels were not significantly affected by the fire. The third ply charred at some locations, but remained mostly unaffected.

After the fire demonstration, it was observed that only the surface ply of the CLT wall panels inside the apartment was charred. The four inner plies of the CLT wall panels were not affected by the fire. The exterior side of the CLT panels had no char.

Figure 32. Inside of the fire compartment after the fire demonstration.

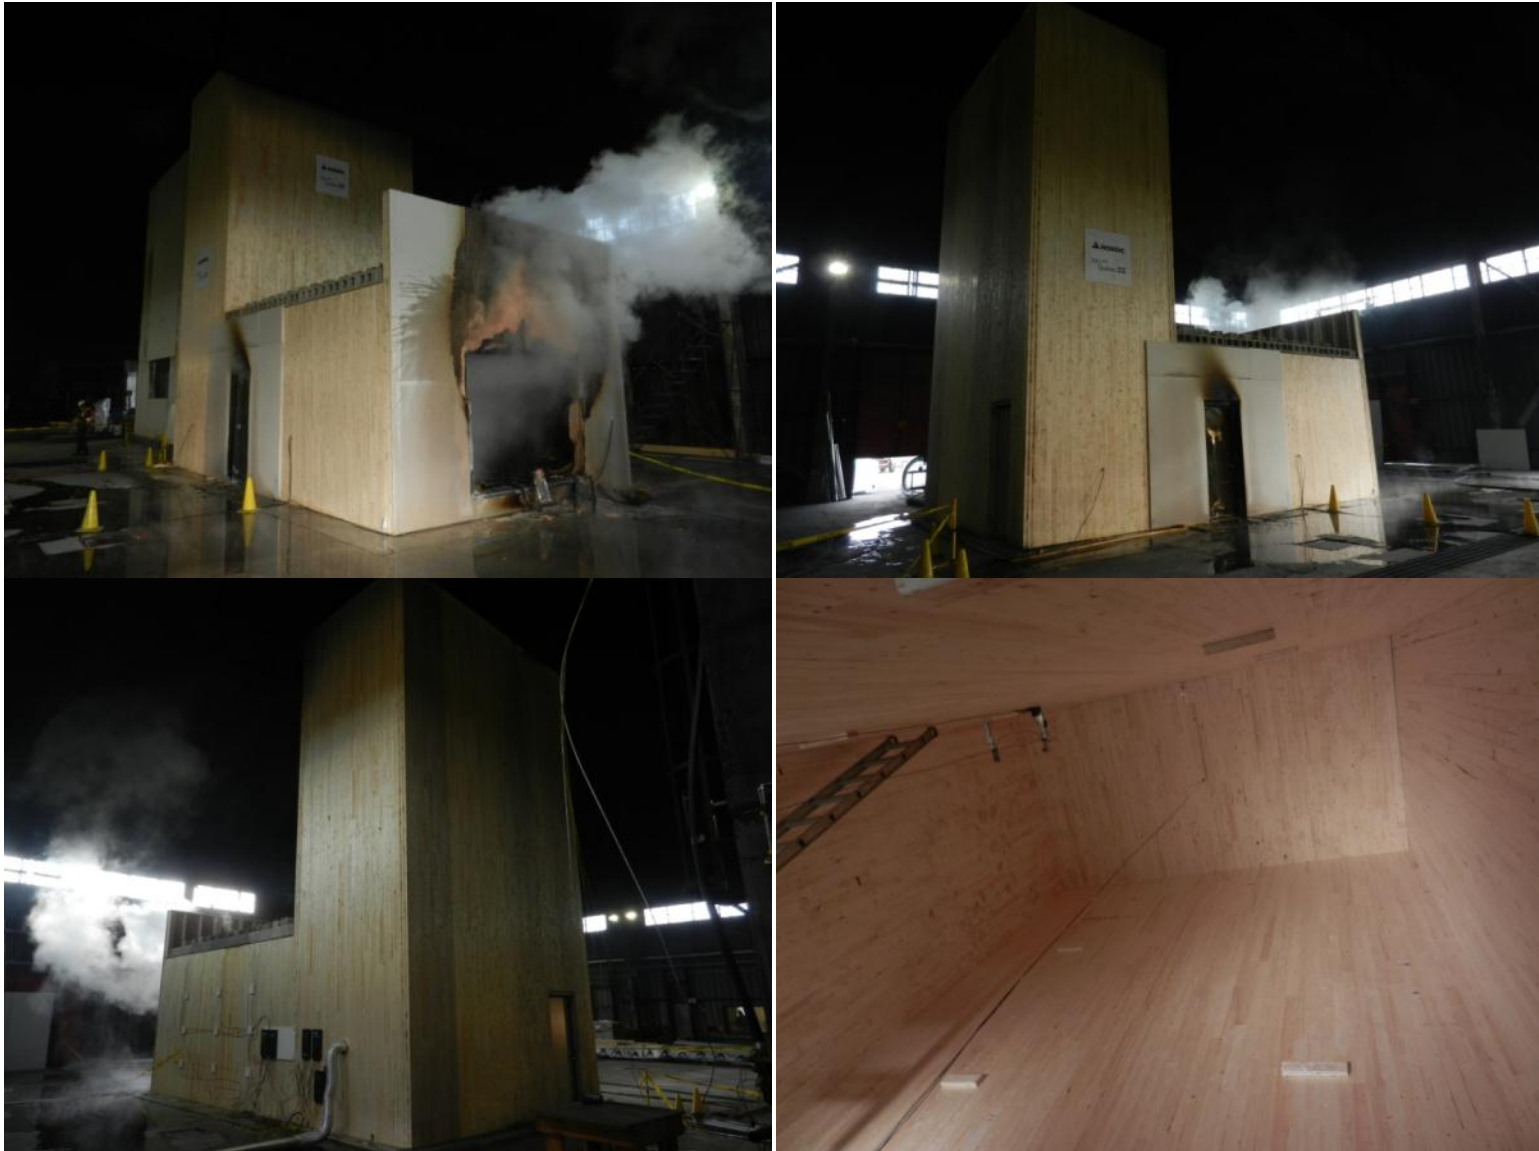
After the demonstration, it was observed that there was less than 5 mm deep char developed on the CLT surface in the upper left quarter. The other three quarters had no char on the CLT surface. The impact of the fire on the CLT shaft wall was very limited.

The stair/elevator shaft was pressurized to 12 Pa above ambient. Measurements show that no smoke or heat was transferred into the stair/elevator shaft. The temperatures measured on the shaft side of the shared CLT wall had no temperature increase during the demonstration. There was no sign of any impact of fire or smoke on the safety conditions in the stair/elevator shaft.

Figure 33. Outside of the demonstration structure and inside of the stair/elevator shaft after the fire demonstration.
