**Objet : Demande d'accès à l'information**

## Site Characterization Report

| <div>Ministère des<br/>Ressources naturelles<br/>et des Forêts</div> <div>Québec</div> <div>Direction de la restauration des sites miniers</div> | <div>Fiche d'inspection<br/>des sites miniers</div> <div>Région 10 : Nord-du-Québec<br/>Coba : 8341-0591</div> | <div>ICON SULLIVAN</div> | <div>2023-08-29</div> |

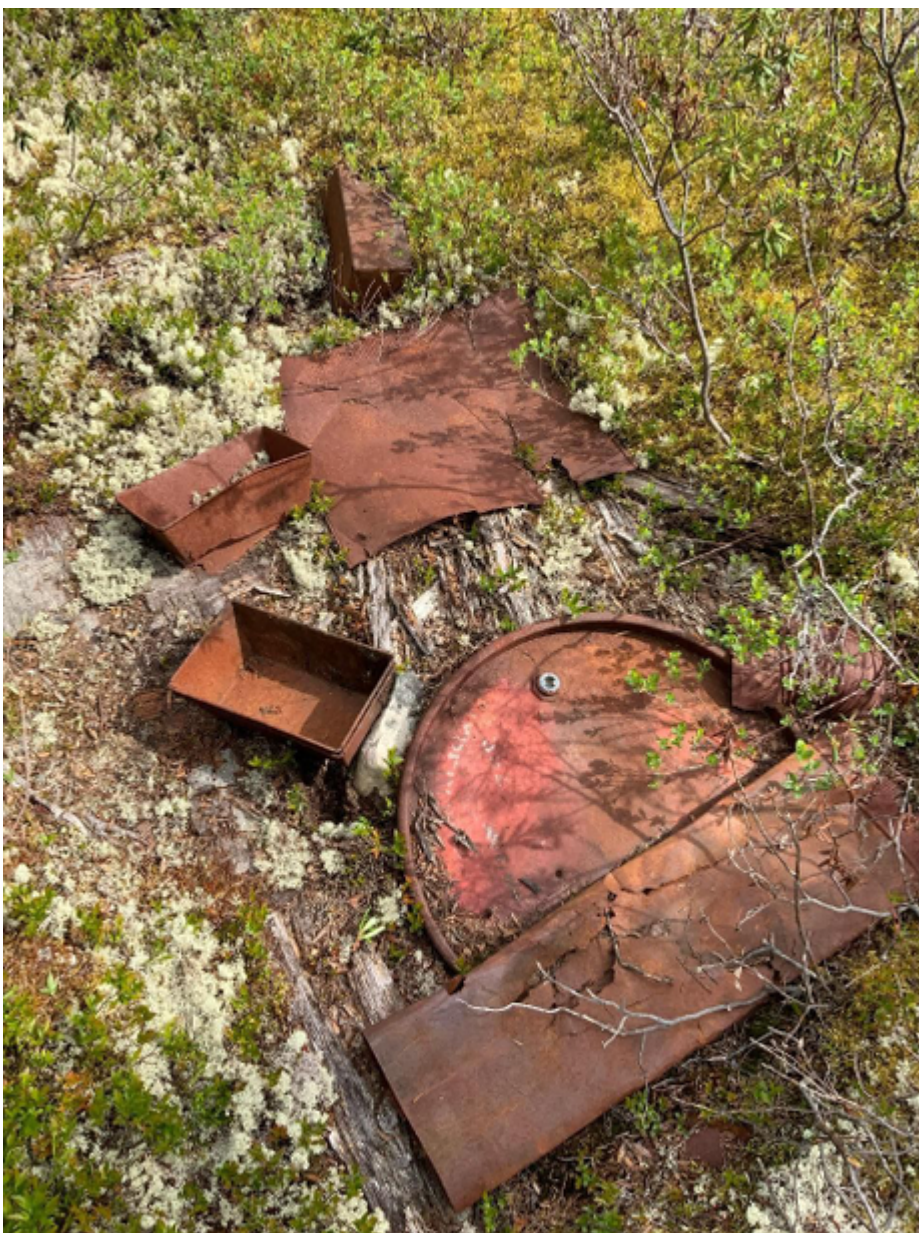
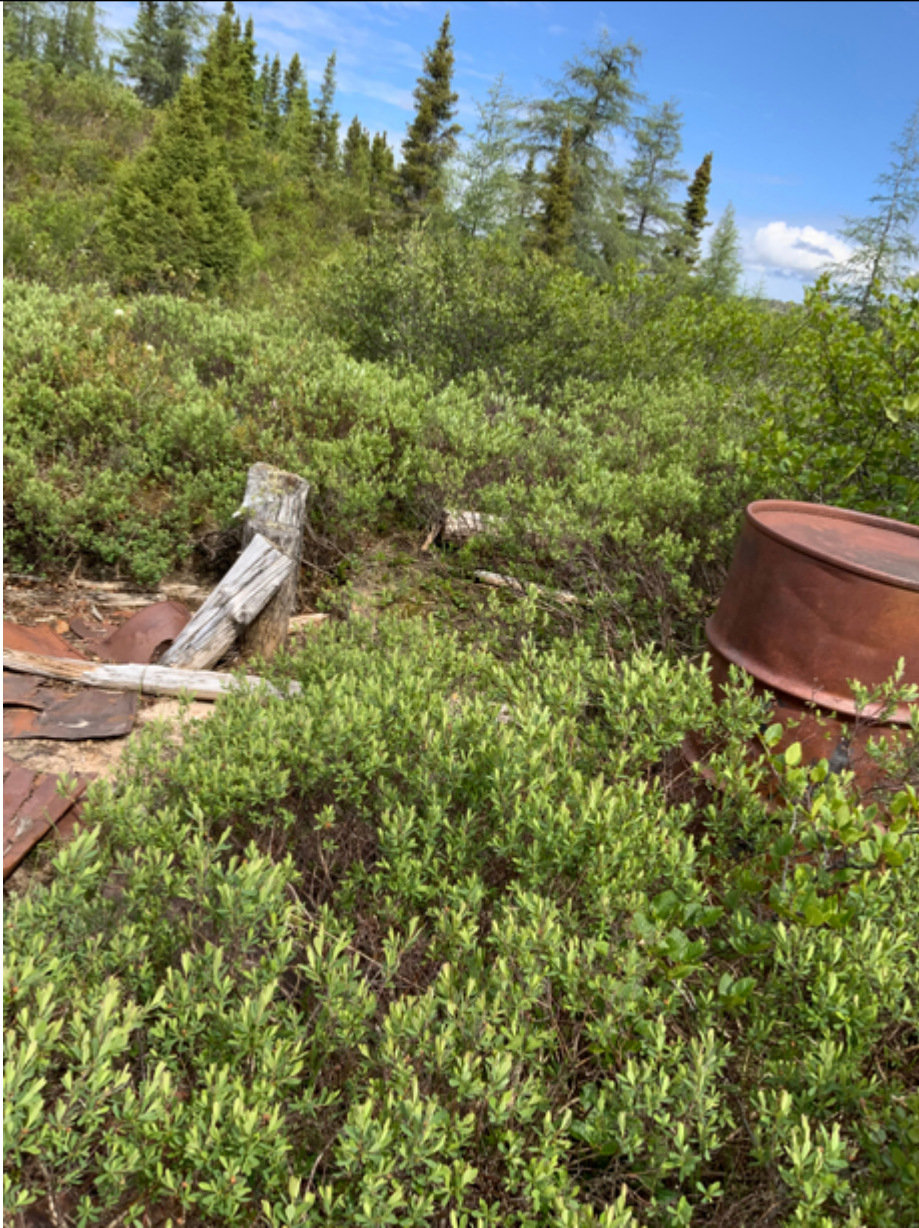
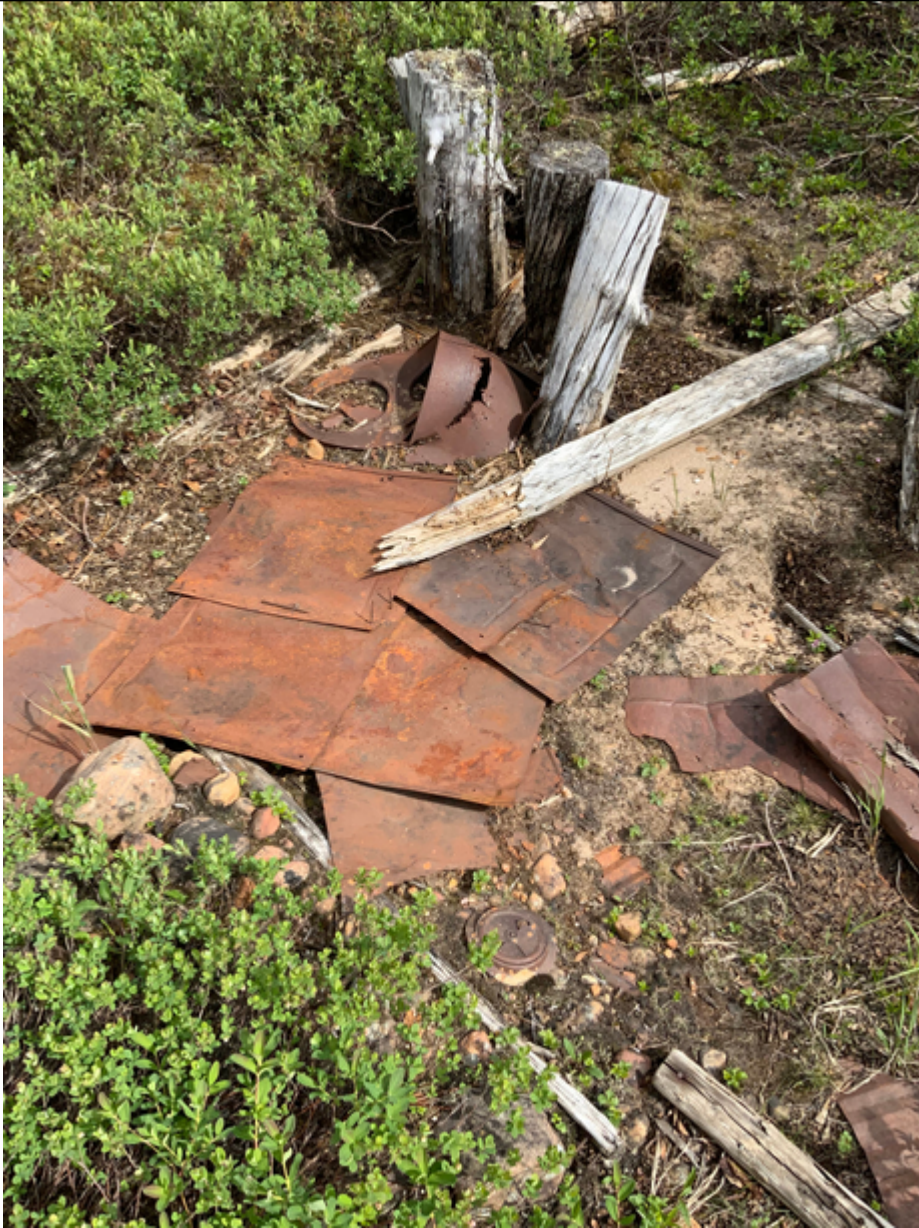
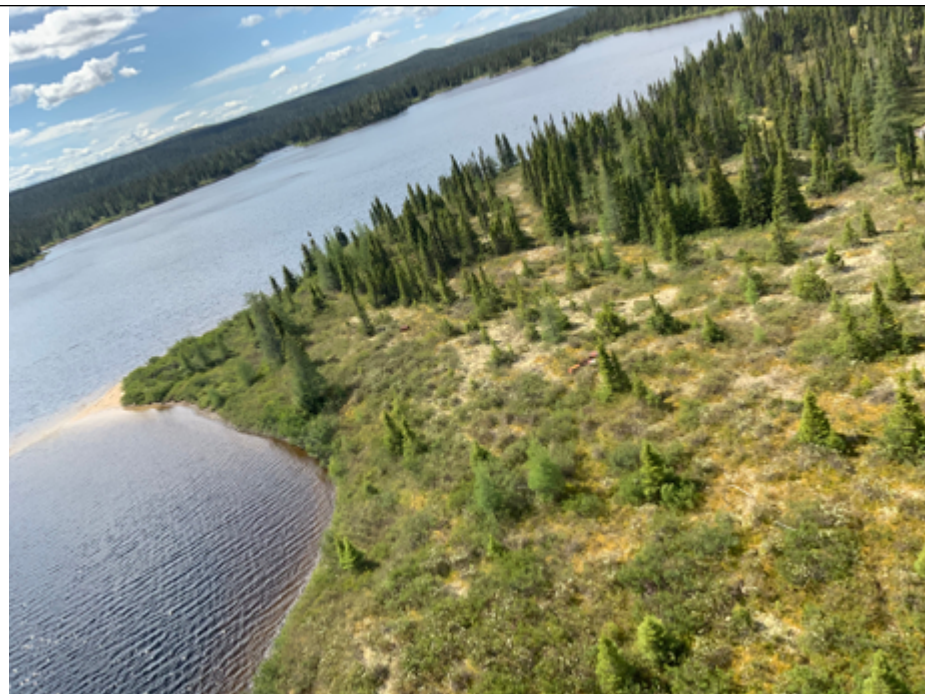
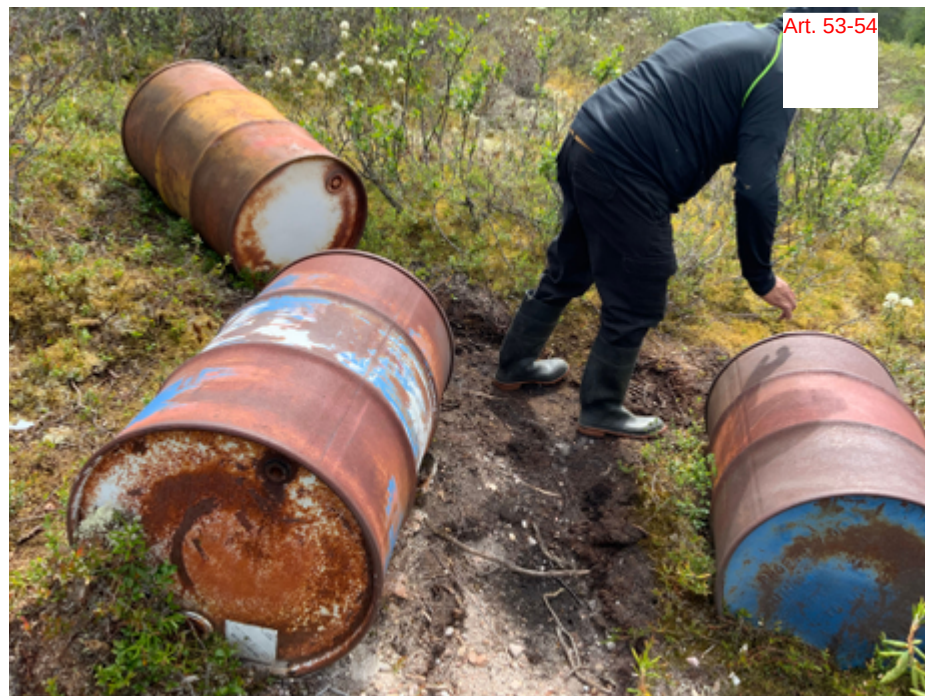
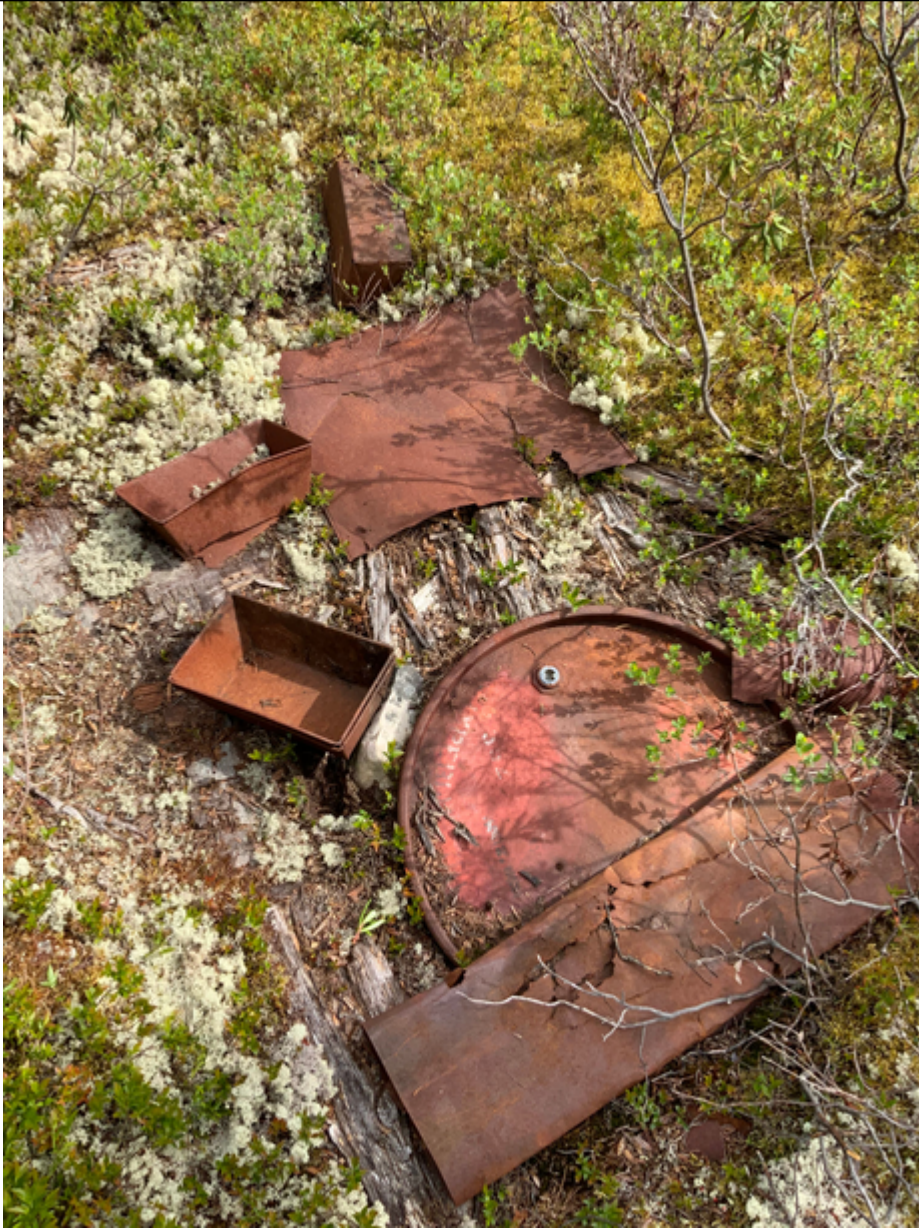
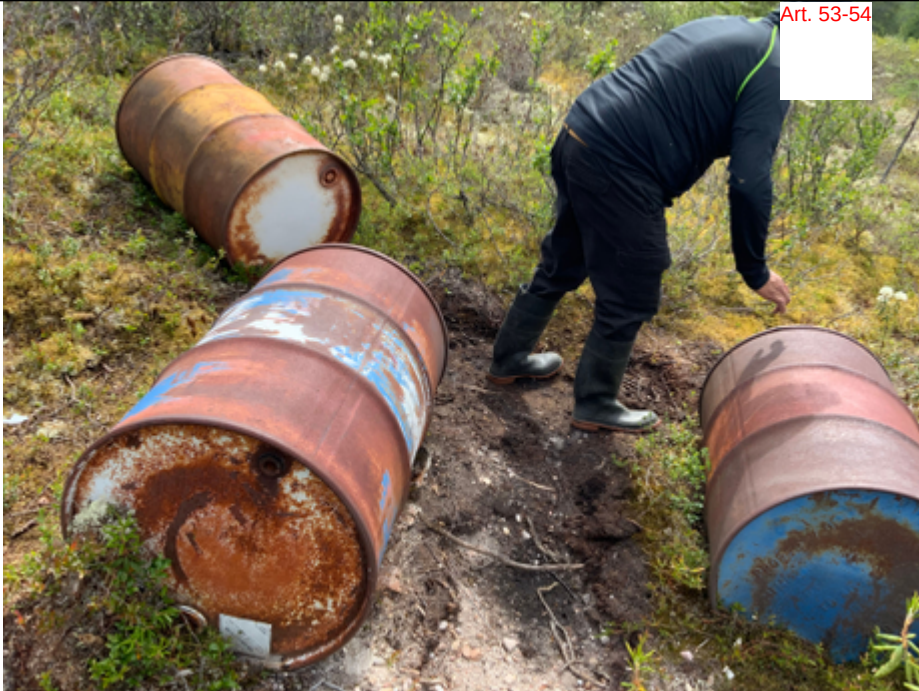
| <b>Other Information :</b><br>Camp reclaimed by nature, old stove pipes and other metal pieces. Very rusty. Helicopter can land on the point. Could be cleaned in 1 day by sling with 2 workers .s\ | |

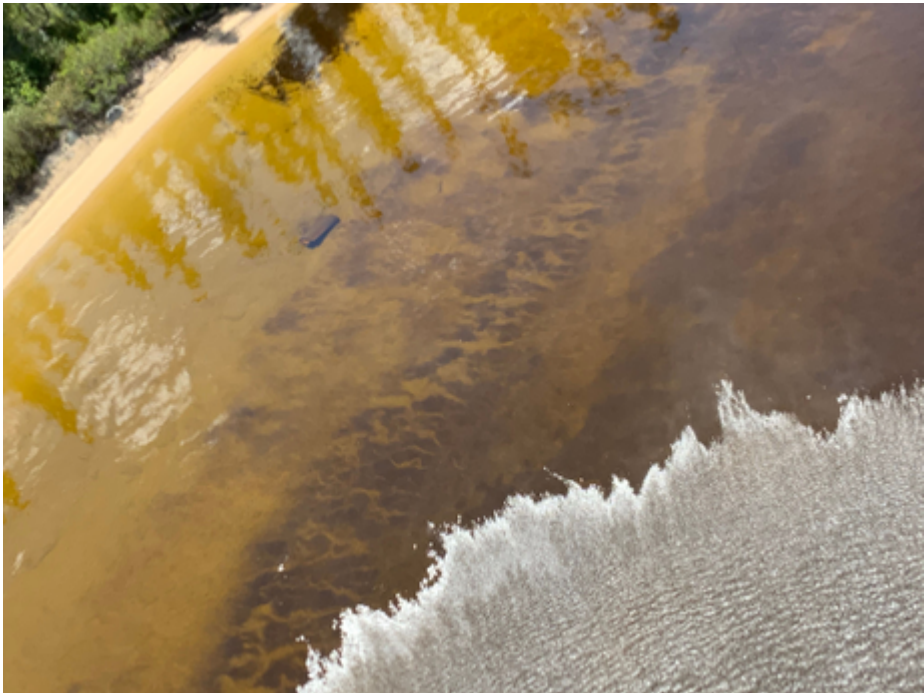
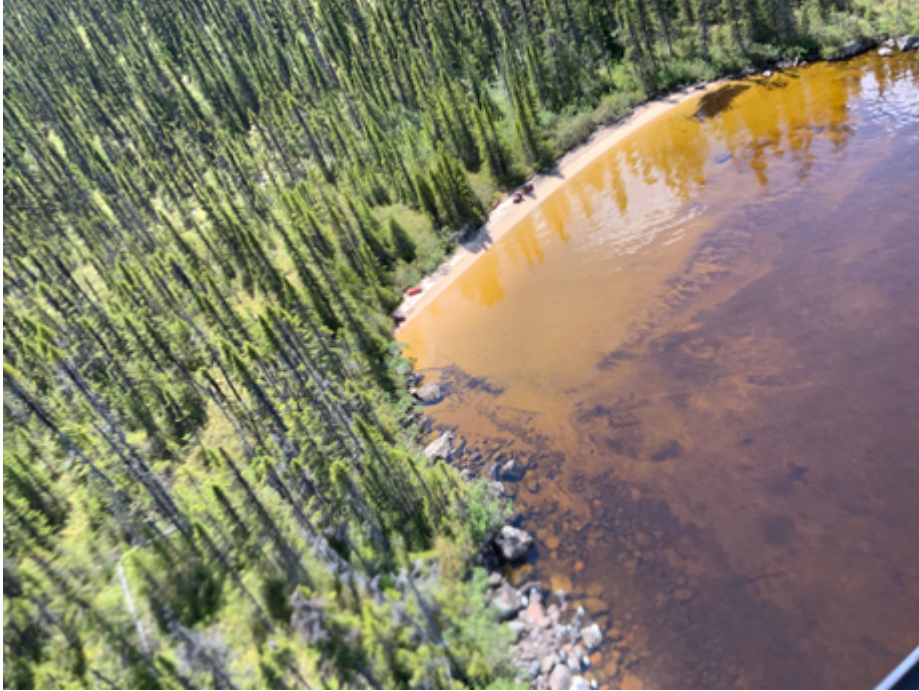
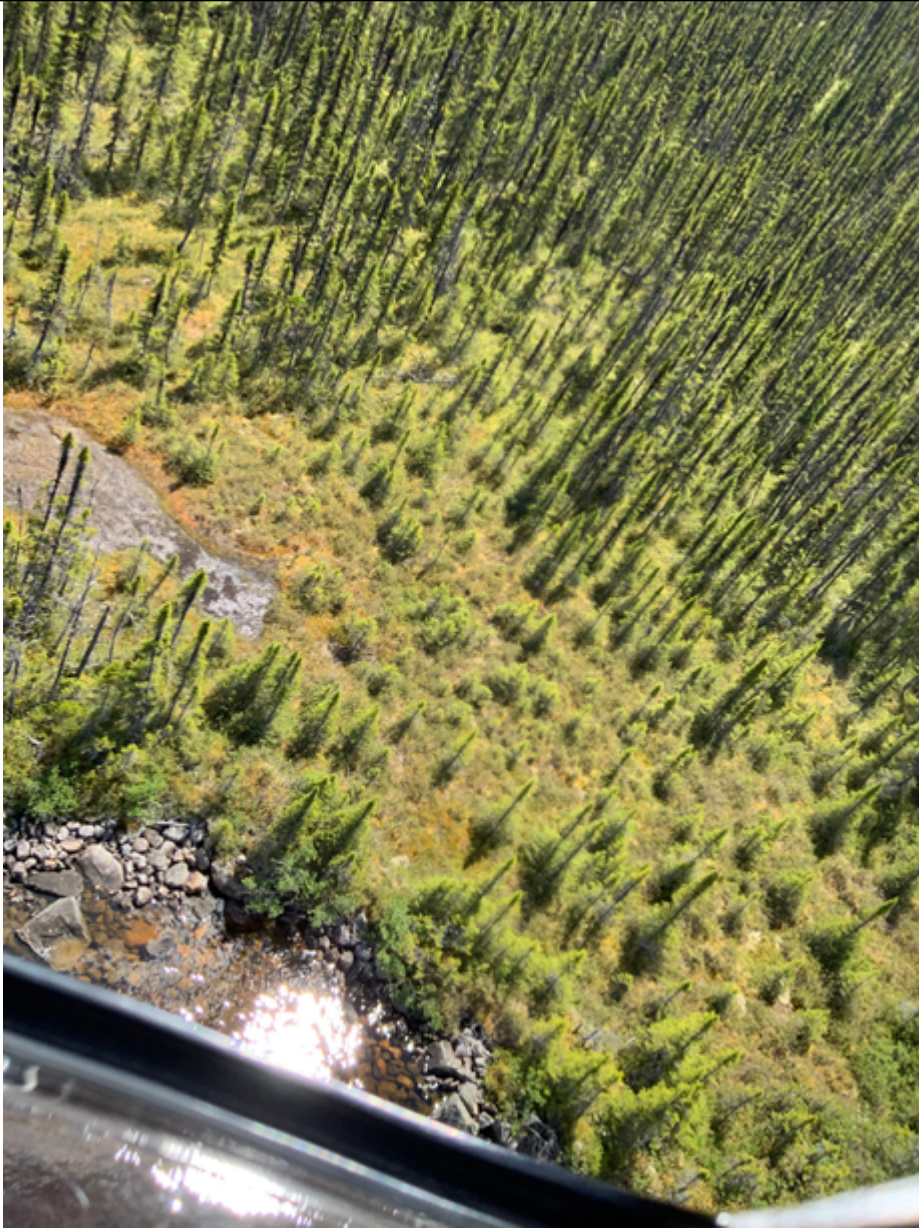
| <b>Other Information :</b><br>Couldn't land, to many trees . Need to cut a pad or go by float plane . Need to go back to check if drums are empty | |

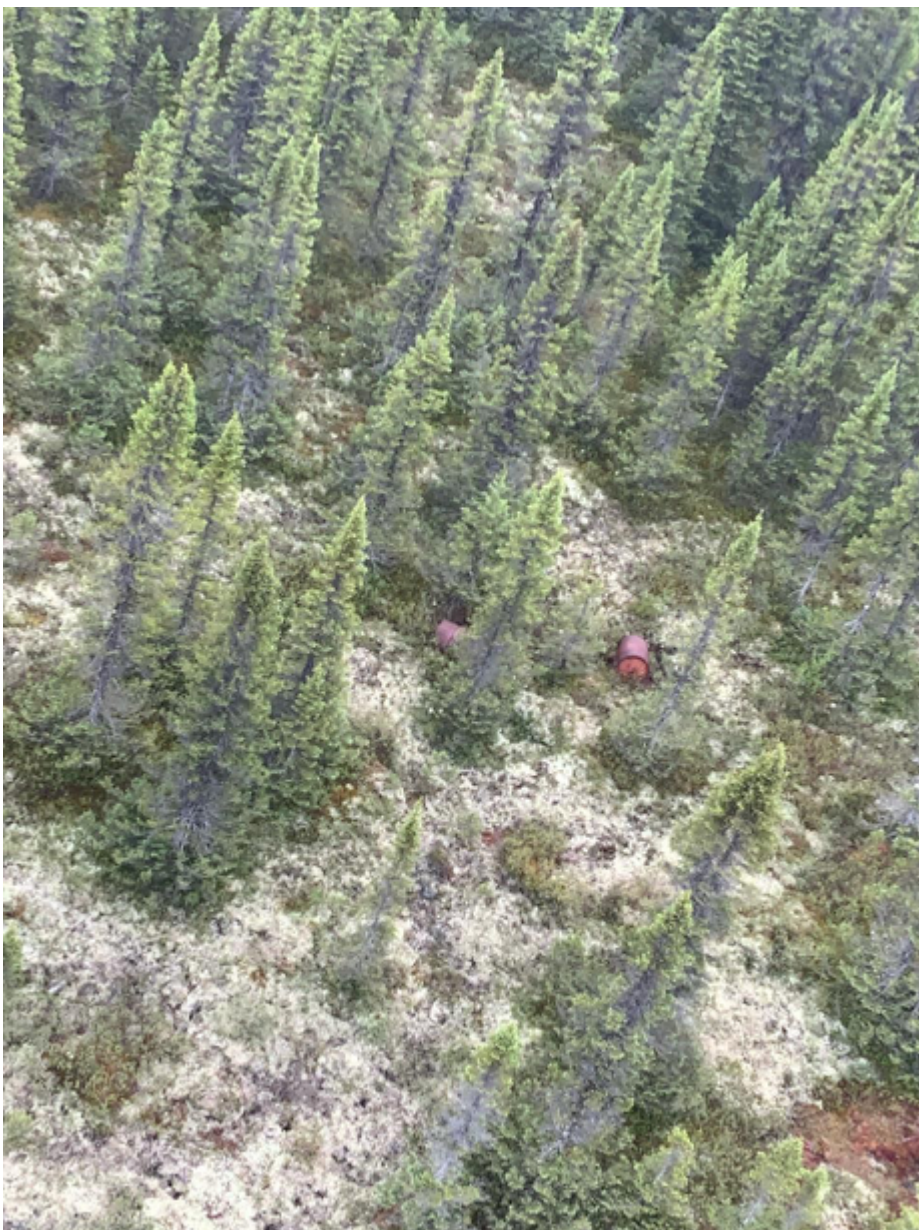
| <b>Other Information :</b><br>2 old drums on site , unsafe to land , took pictures. Tall man says drums are empty | |

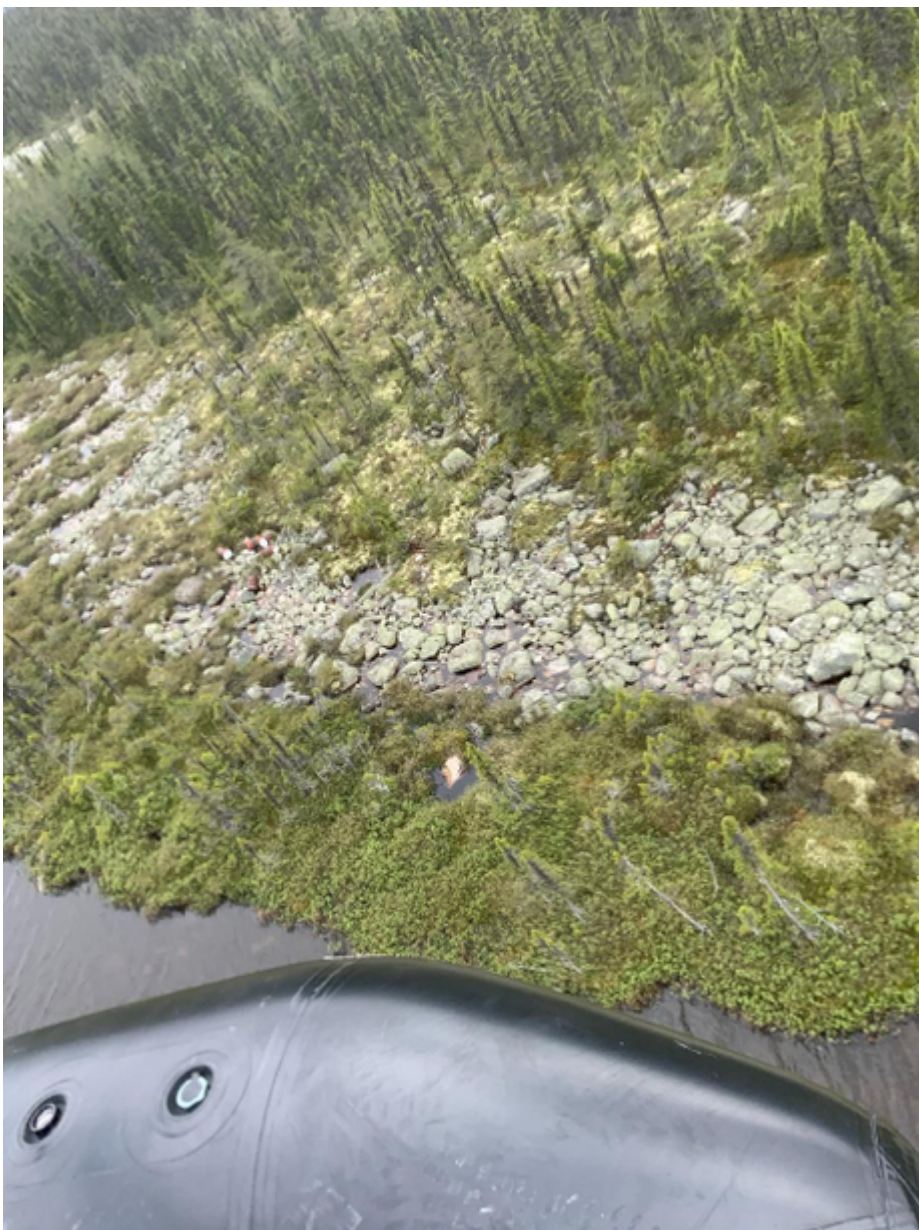
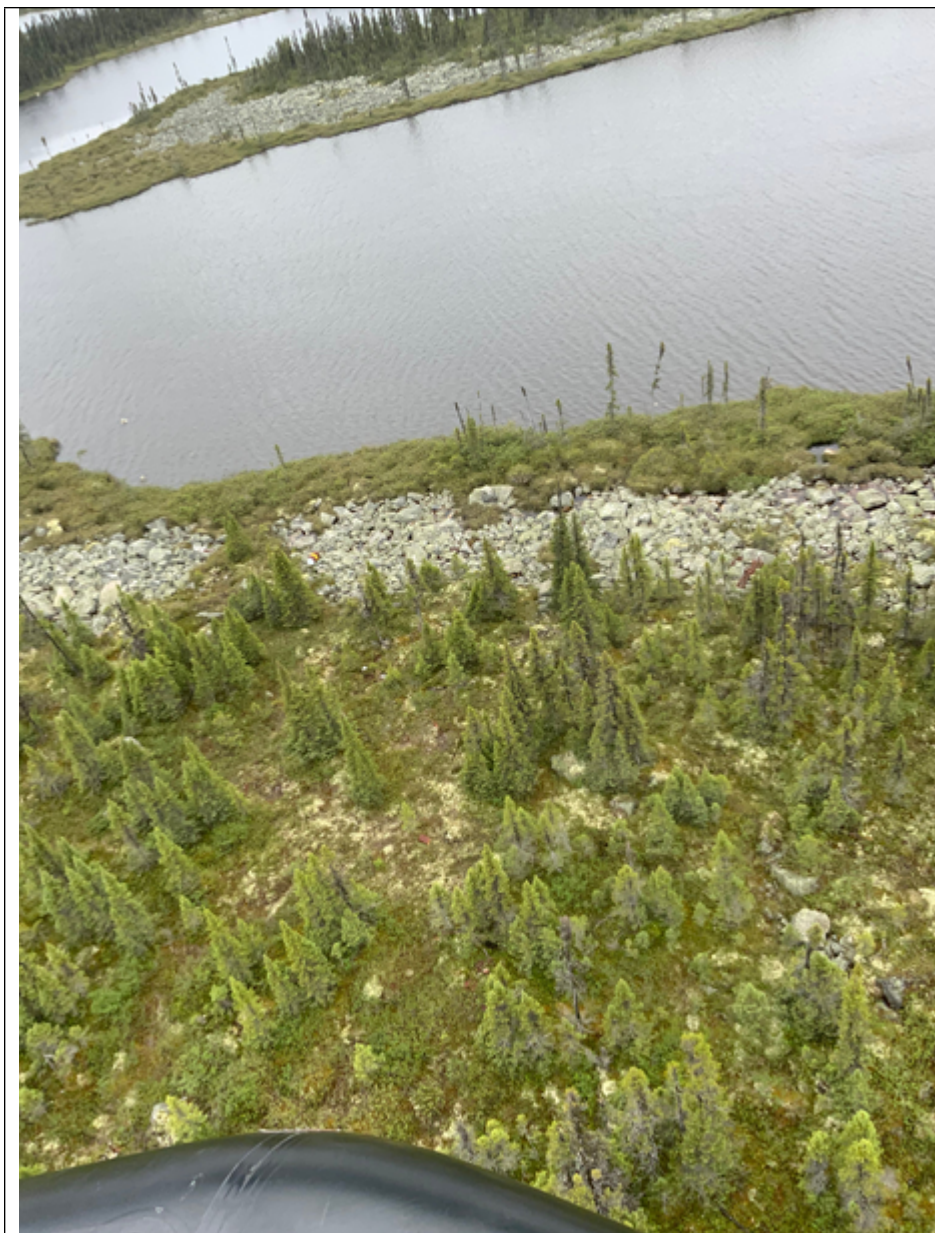
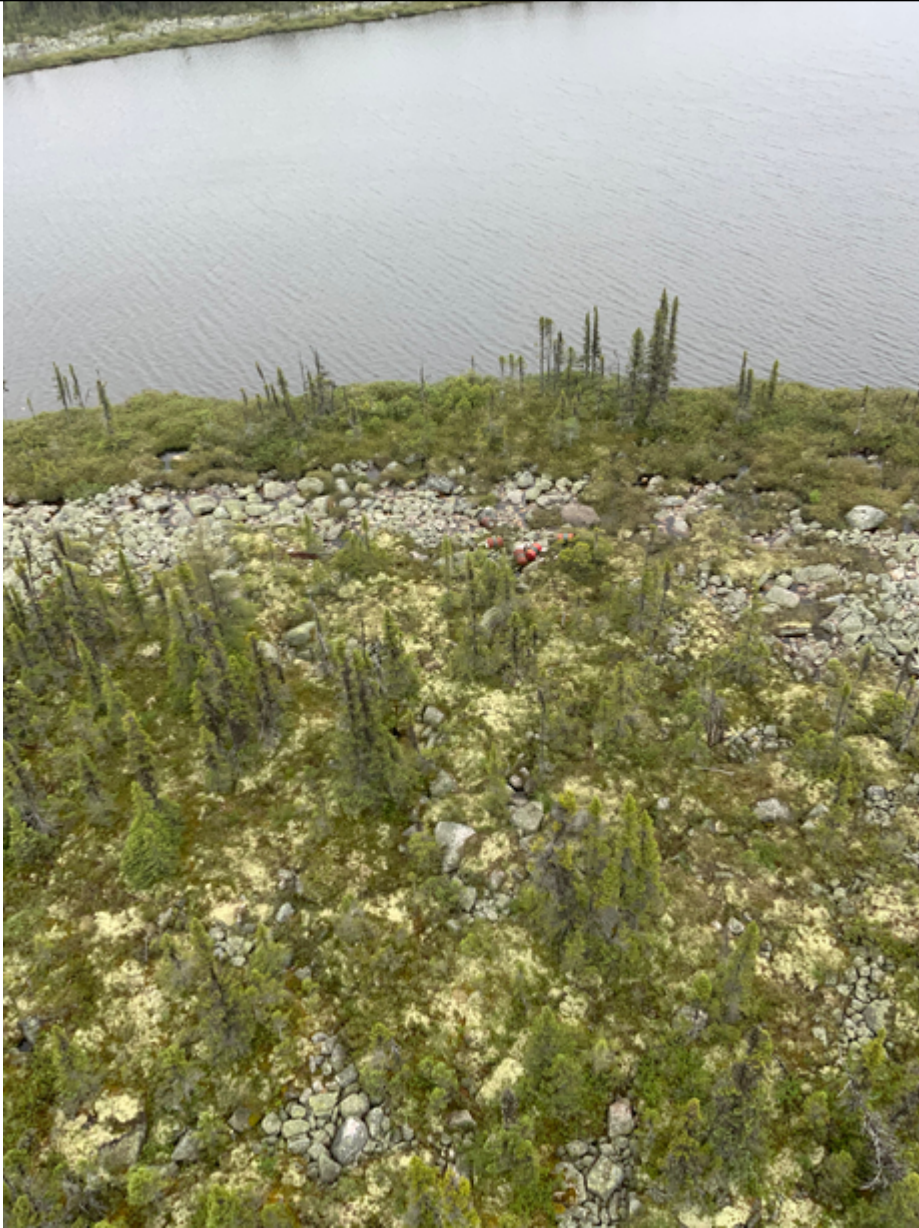
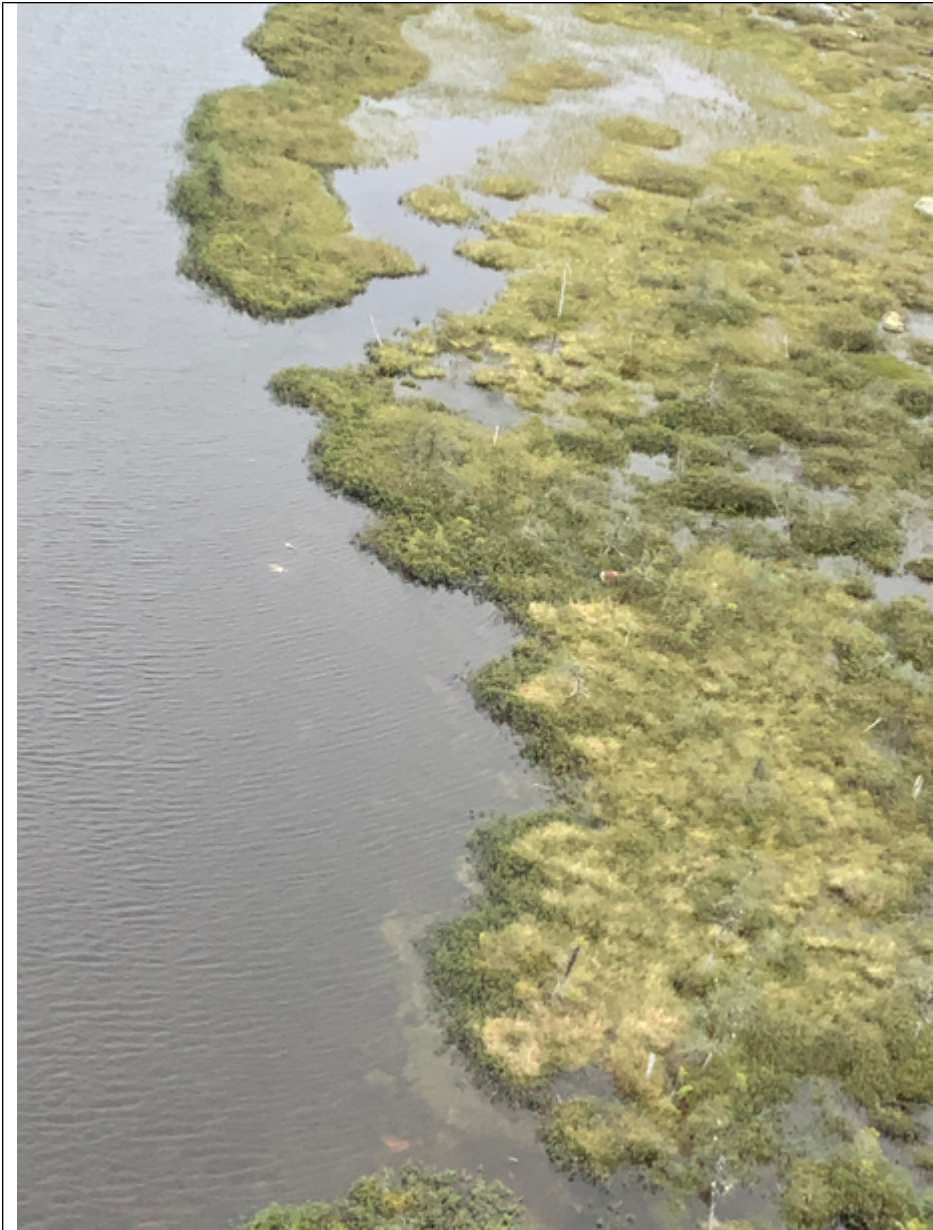
| <b>Other Information :</b><br>5 drums in one spot in fair condition. 3 other drums spread out along shore. | |

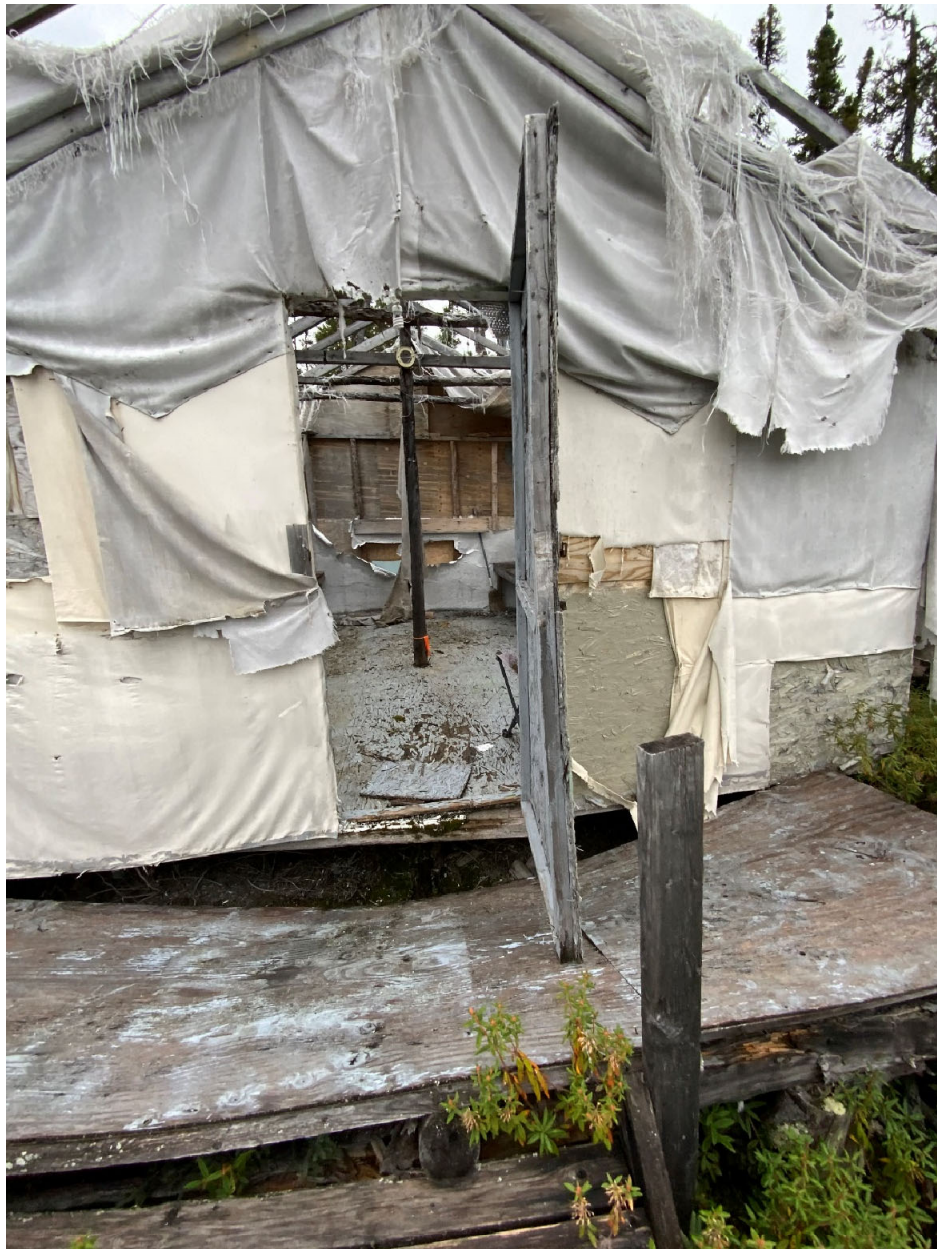
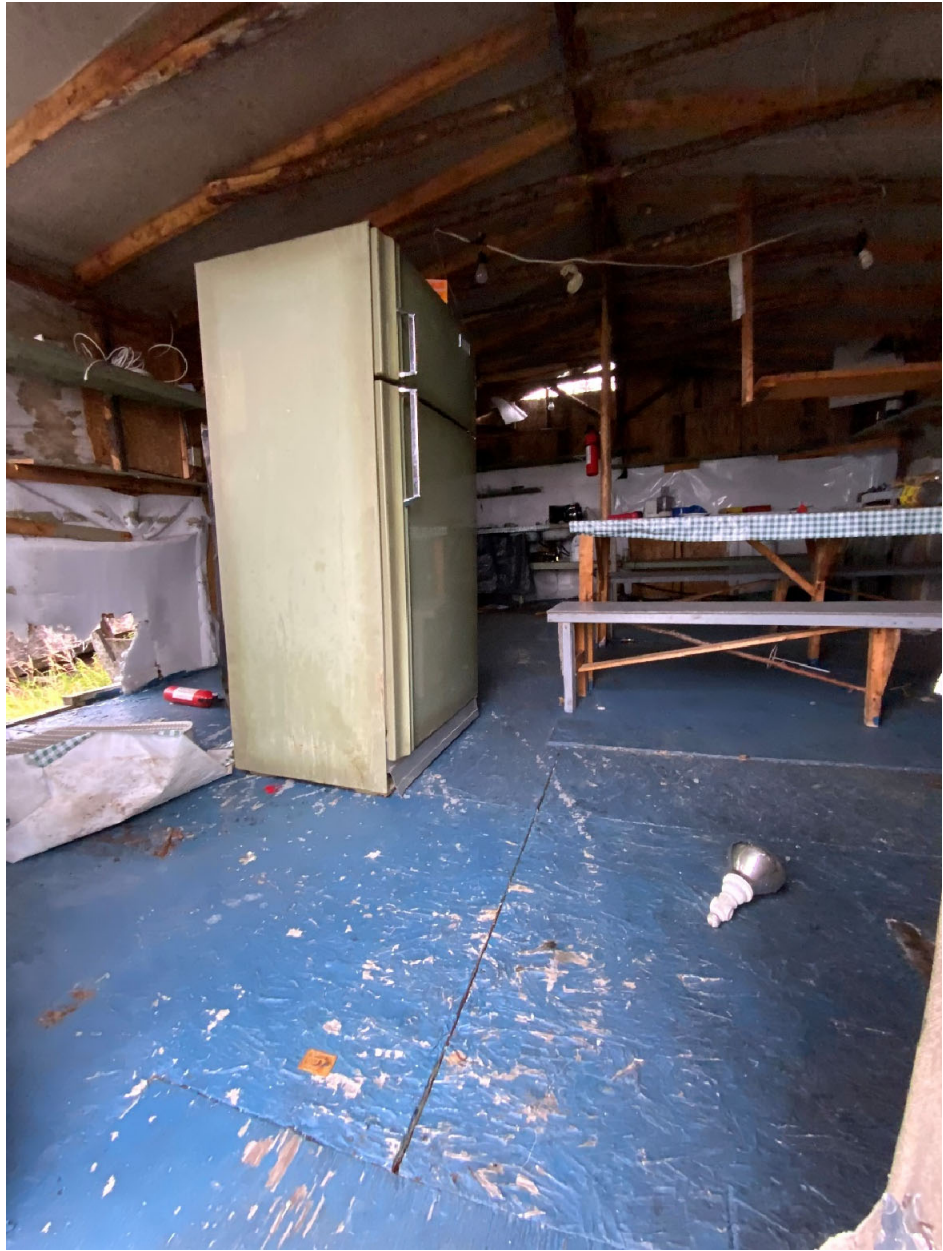
**MI/21-326**

**1 fridge , 1 hot water tank,1 washing machine,1 water pump. Belonged to a company named Dios about 16 years ago according to tallyman.**

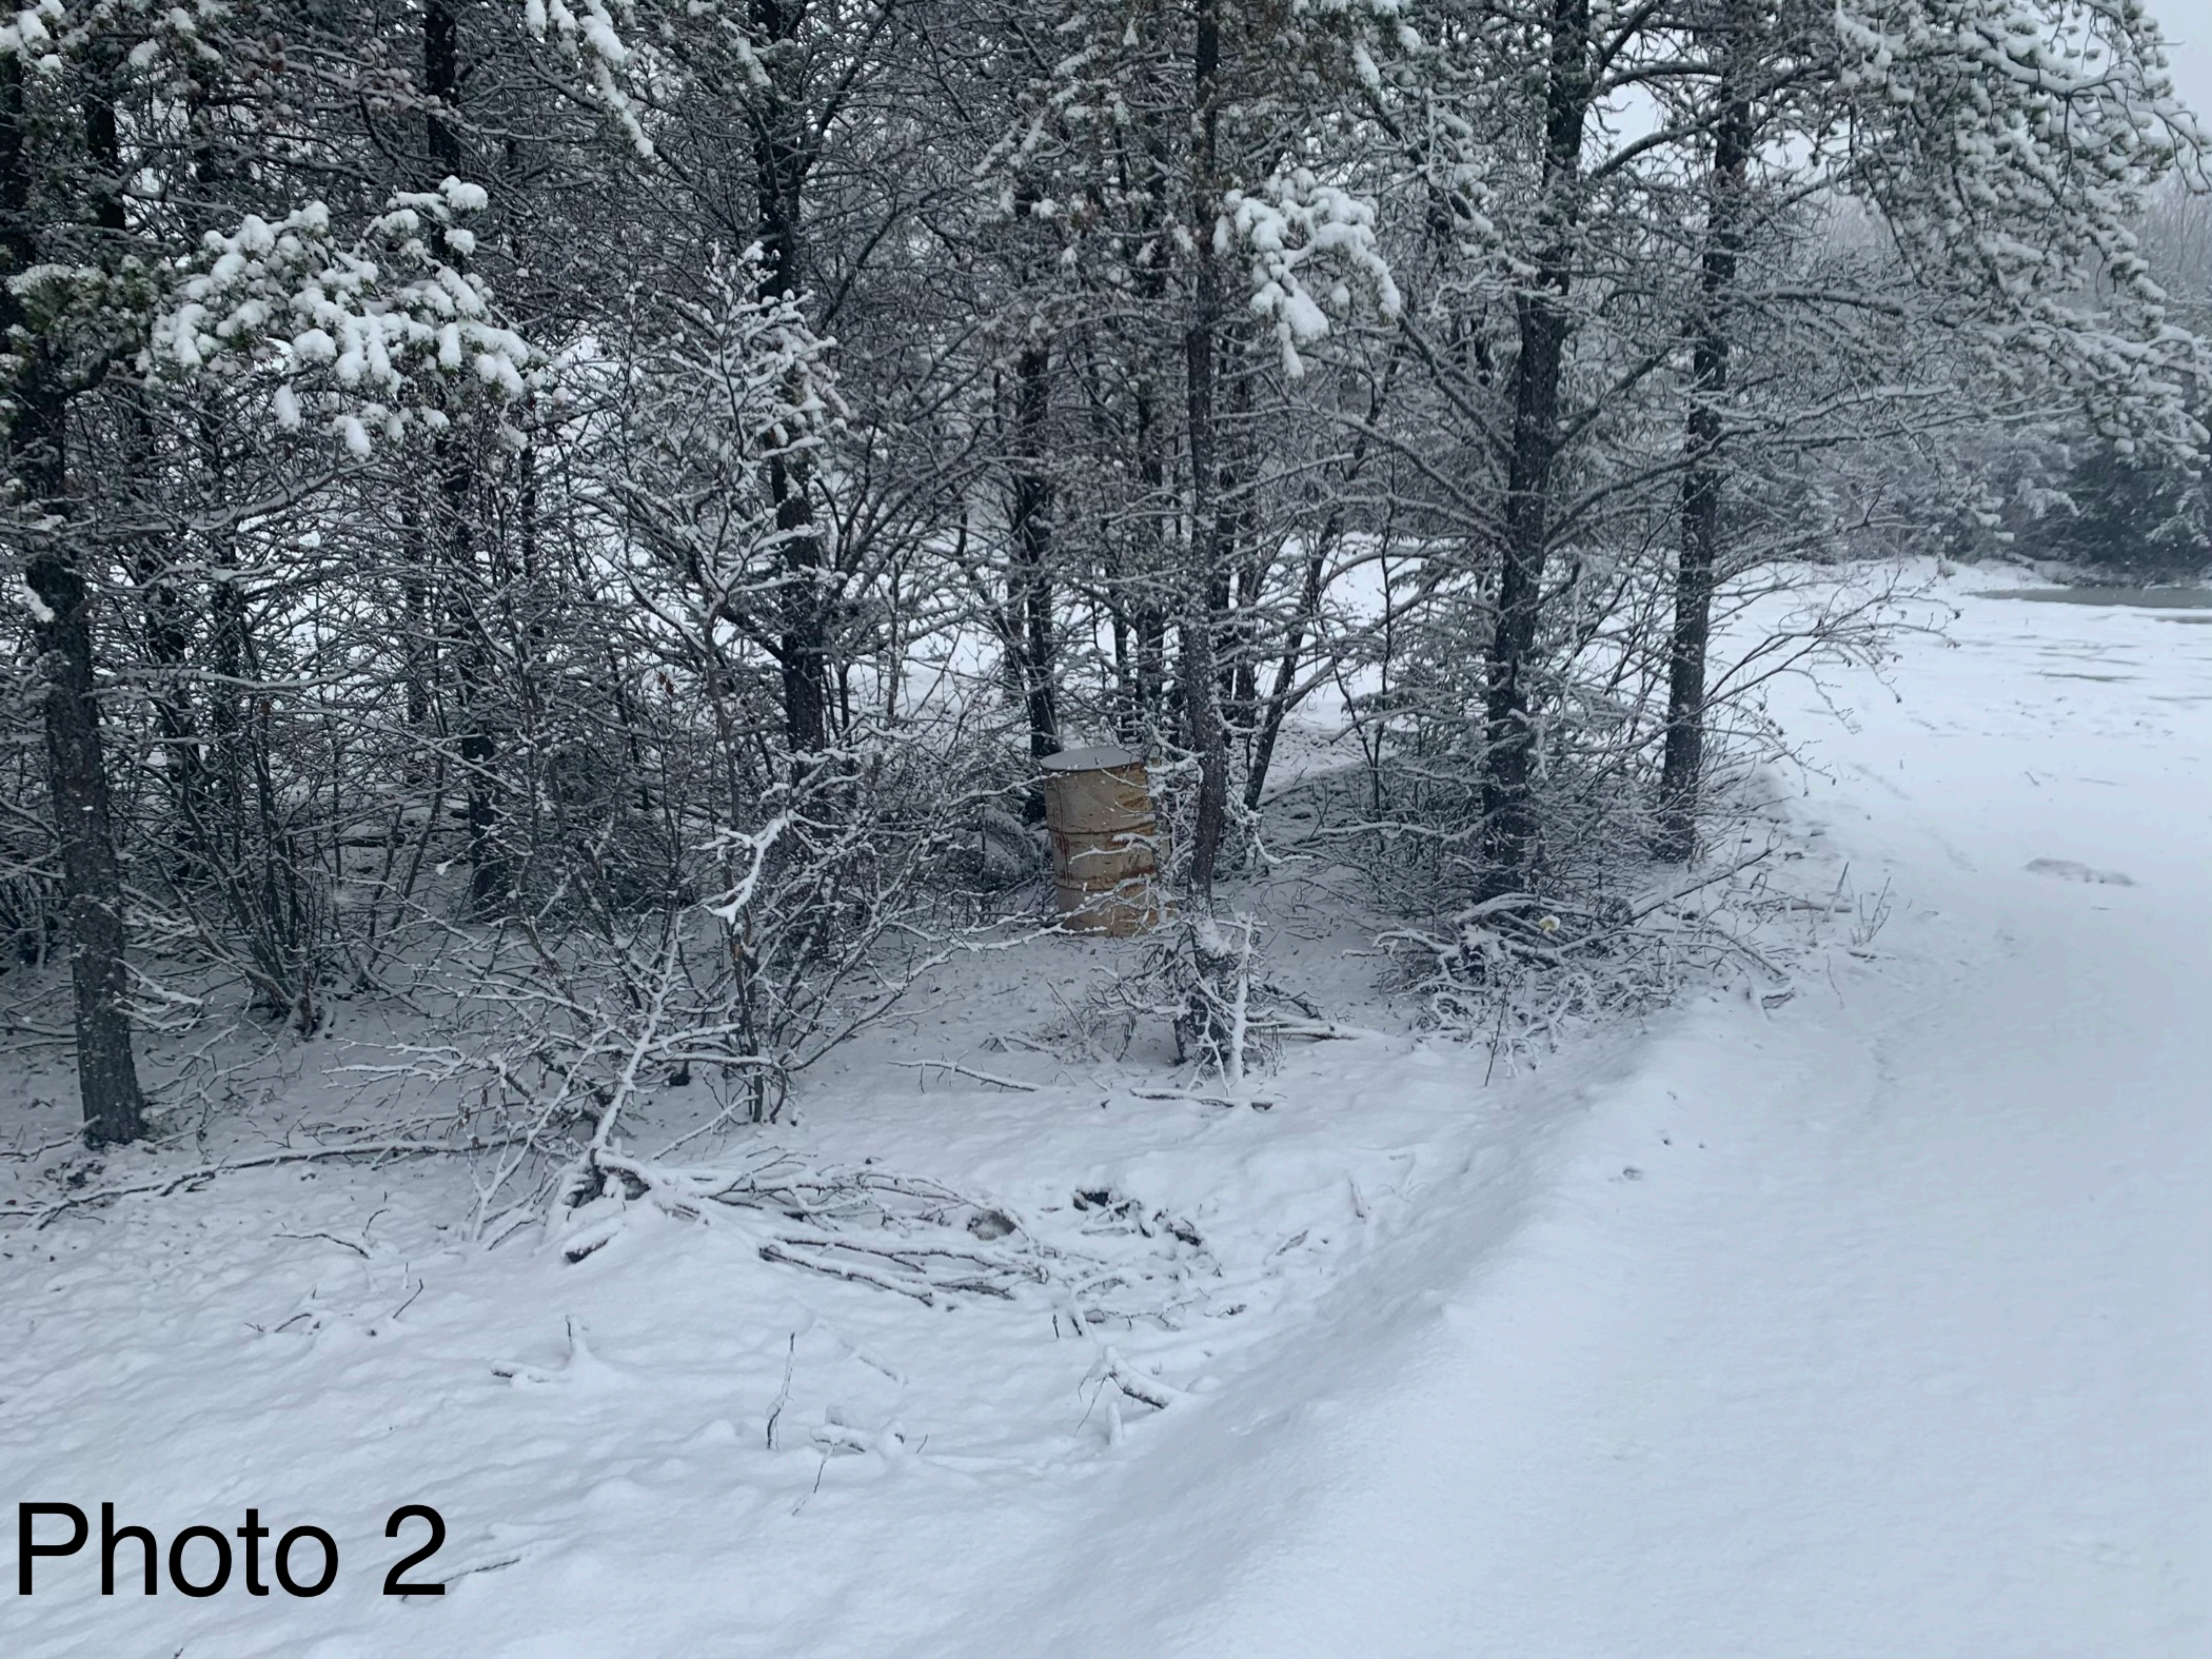
Photo 2

L'épaisseur de  
la terre végétale  
est très faible  
(env. 3 cm)

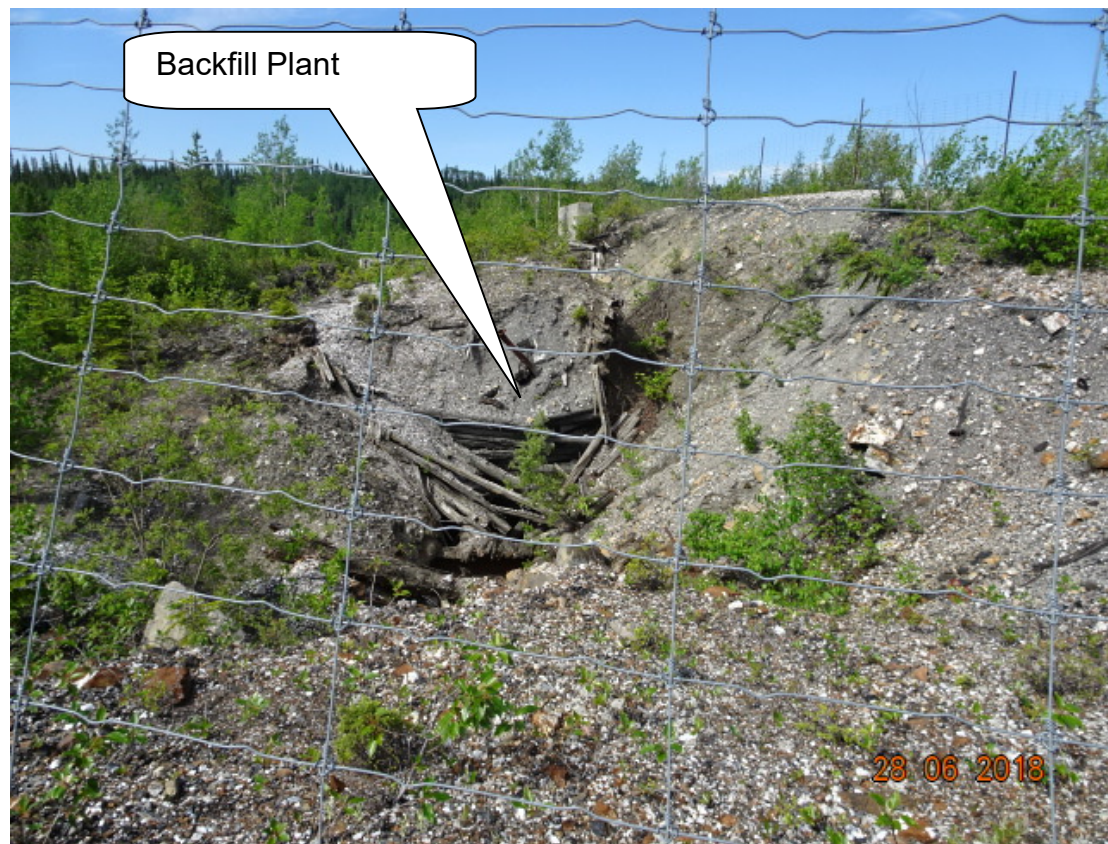
**IS-2018-06-28-006** – Du côté Est, affaissement au Backfill Plant  
(vue vers l'Ouest)  
**Coordonnées UTM Nad83 : 584908 Est, 5565749 Nord**

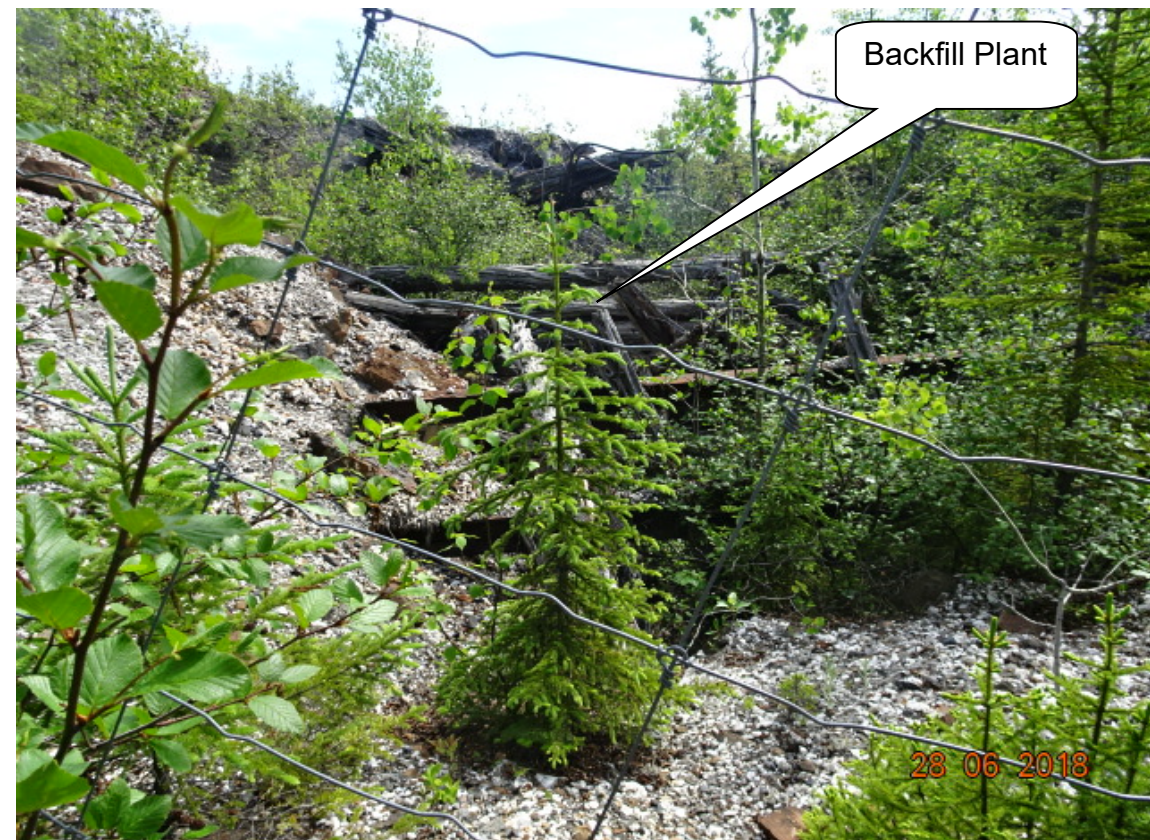
**IS-2018-06-28-007** – Du côté Ouest, affaissement au Backfill Plant  
(vue vers l'Est)  
**Coordonnées UTM Nad83 : 584861 Est, 5565719 Nord**
