**Objet : Demande d'accès à l'information**

## Site Characterization Report

| <div>Ministère des<br/>Ressources naturelles<br/>et des Forêts</div> <div>Québec</div> <div>Direction de la restauration des sites miniers</div> | <div>Fiche d'inspection<br/>des sites miniers</div> <div>Région 10 : Nord-du-Québec<br/>Coba : 8341-0591</div> | <div>ICON SULLIVAN</div> | <div>2023-08-29</div> |

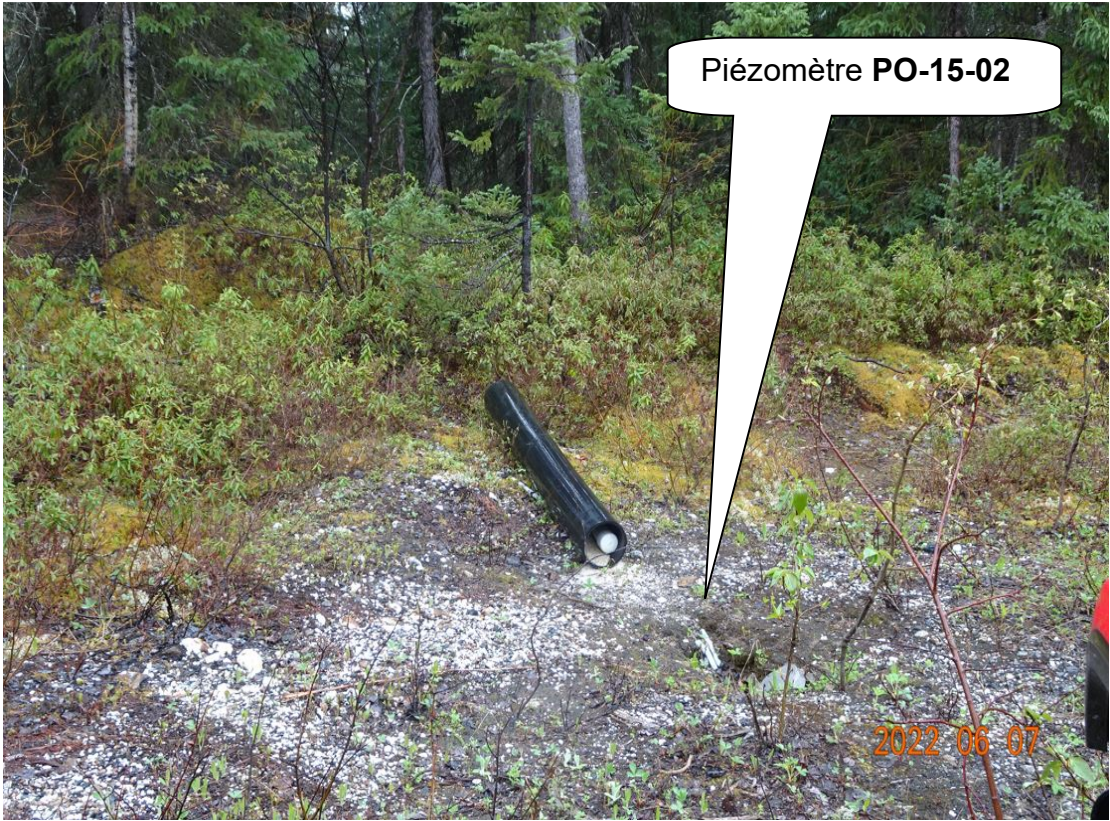
**IS-2022-06-07-003** – Piézomètre **PO-15-02** coupé au déneigement hiver  
2018 (vue vers le Sud-Ouest)  
**Coordonnées UTM Nad83 : 585207 Est, 5566398 Nord**

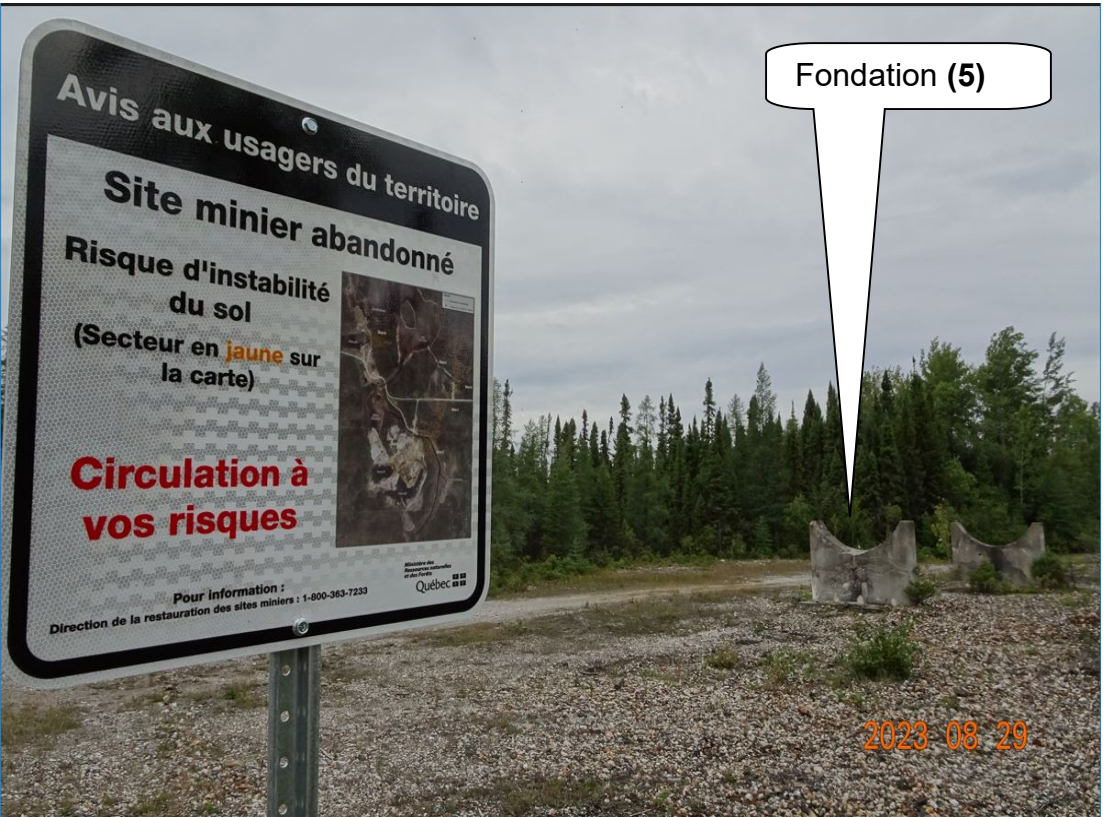
IS-20232023-08-29-001 – Affiche Danger sol instable et fondation de béton (5)  
(vue vers le Nord)  
Coordonnées UTM Nad83 : 585300 Est, 5566212 Nord

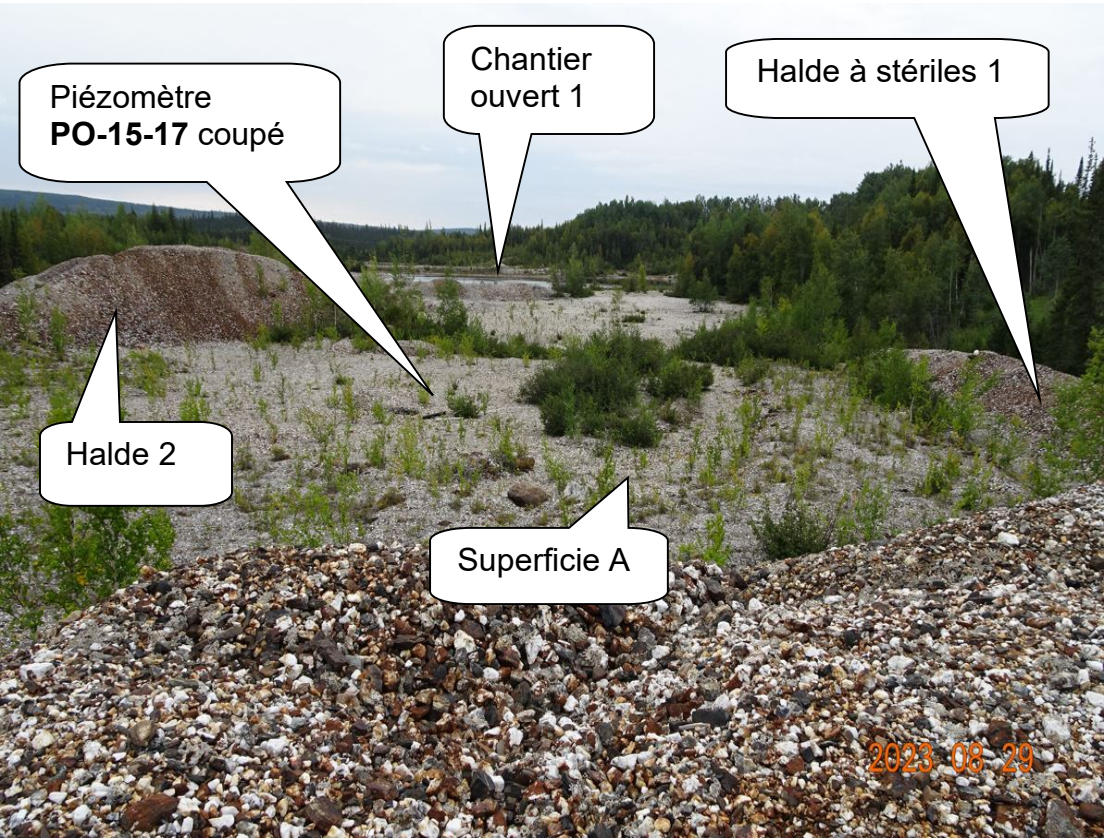
**IS-2023-08-28-005** – Piézomètre **PO-15-17** coupé, les haldes 1 et 2 et  
chantier ouvert 1 (vue vers le Sud)  
**Coordonnées UTM Nad83 : 584555 Est, 5565933 Nord**

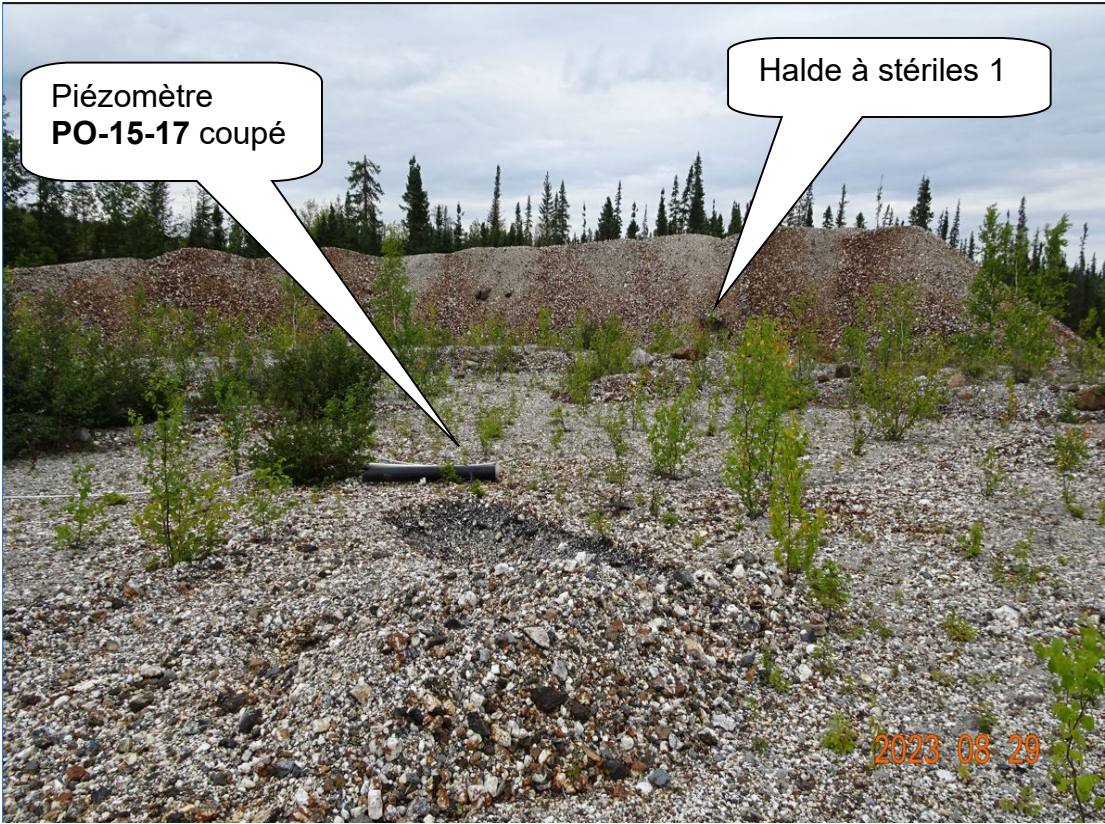
**IS-2023-08-2929-006** – Piézomètre **PO-15-17** coupé en arrière halde stériles 1  
(vue vers le Nord-Ouest)  
**Coordonnées UTM Nad83 : 584585 Est, 5565899 Nord**

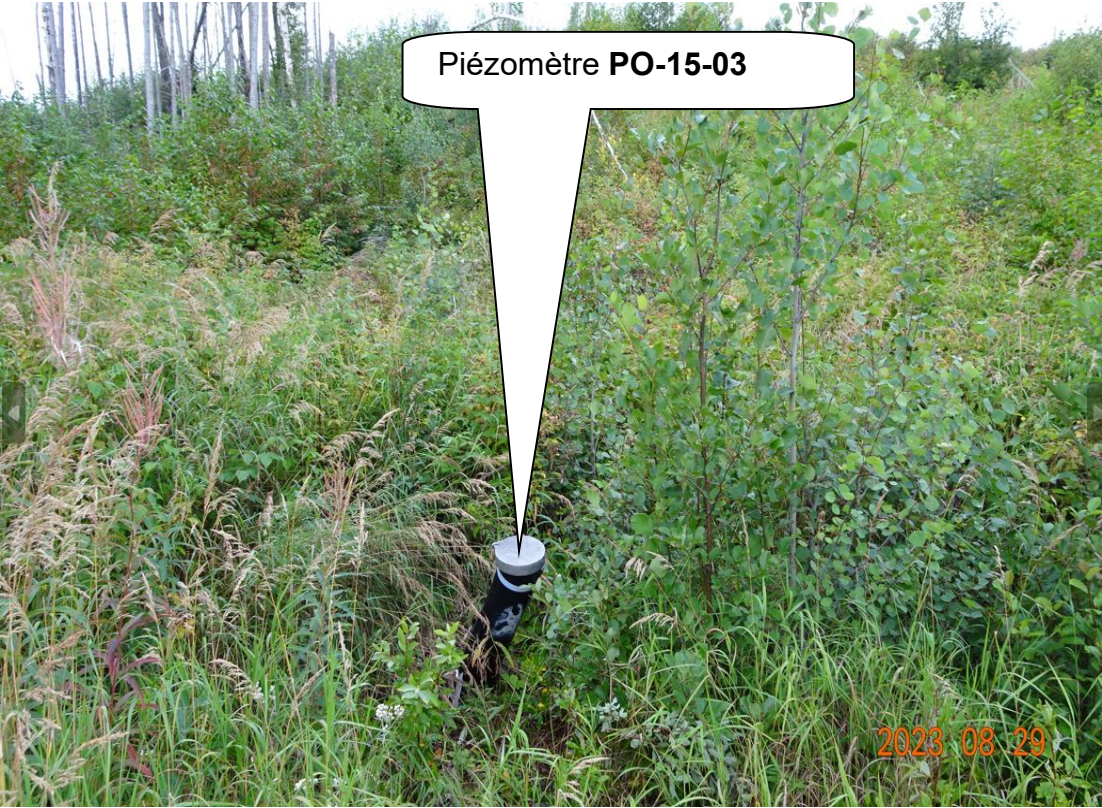
**IS-2023-08-29-009** – Piézomètre **PO-15-03**, a été accroché par cie forestière  
hiver 2019 (vue vers le Nord-Ouest)  
**Coordonnées UTM Nad83 : 584527 Est, 5565821 Nord**
