Objet : Demande d'accès à l'information

Site Characterization Report

Abandoned Mine sites

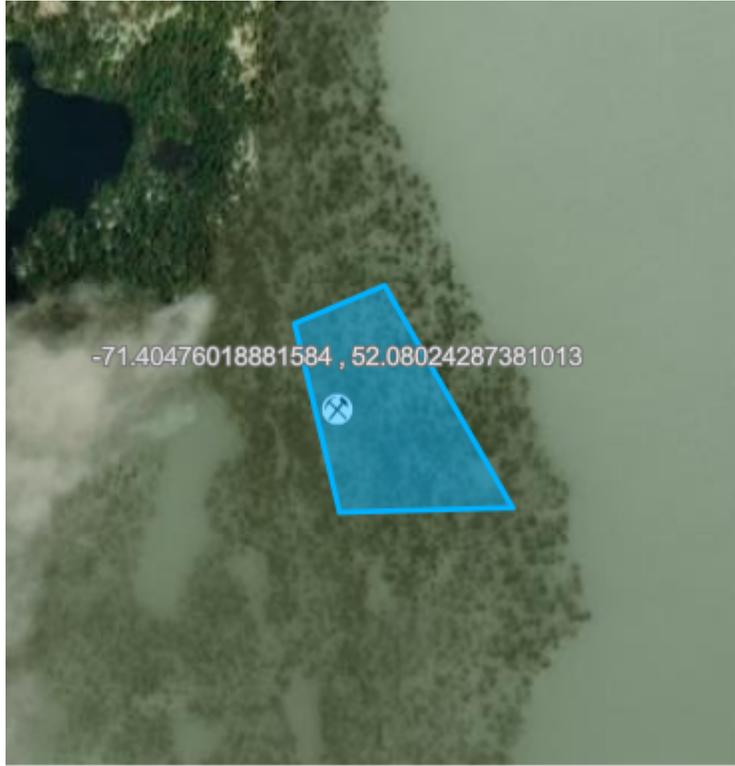
| Drums | | | | | |
|---|---|---|---|---|---|
| Nb total: 8 | | | | | |
| Content: Jet Fuel Name of other: | | | | | |
| Nb of full: | Nb of full: 8 | Nb of full: | Nb of full: | Nb of full: | Nb of full: |
| Distance from a sensitive area (m): Less than 50 m | | | | | |

| Other Information : Couldn't land but tally man confirmed he recently inspected and drums were full. Can easily be cleaned once landing pad is made. | |

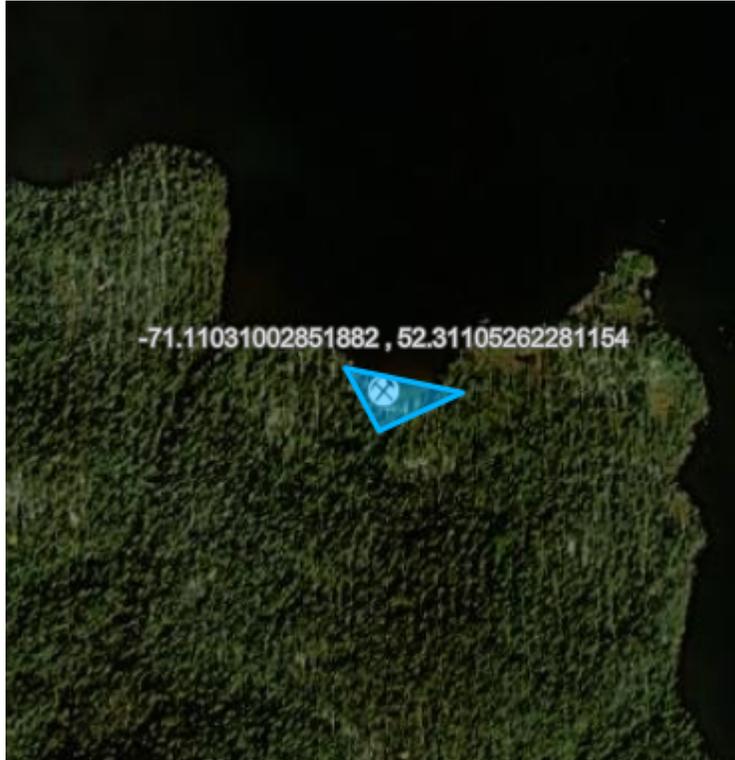
| Drums | | | | | |
|---|---|---|---|---|---|
| Nb total: 11 | | | | | |

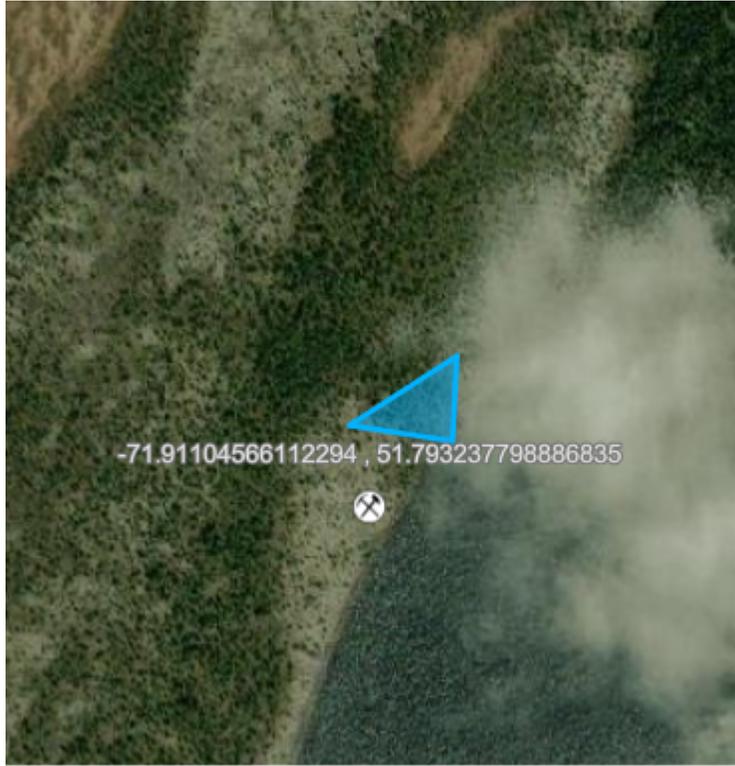
| Drums | | | | | |
|---|---|---|---|---|---|
| Nb total: 2 | | | | | |

| Other Information : 2 old drums on site , unsafe to land , took pictures. Tall man says drums are empty | |

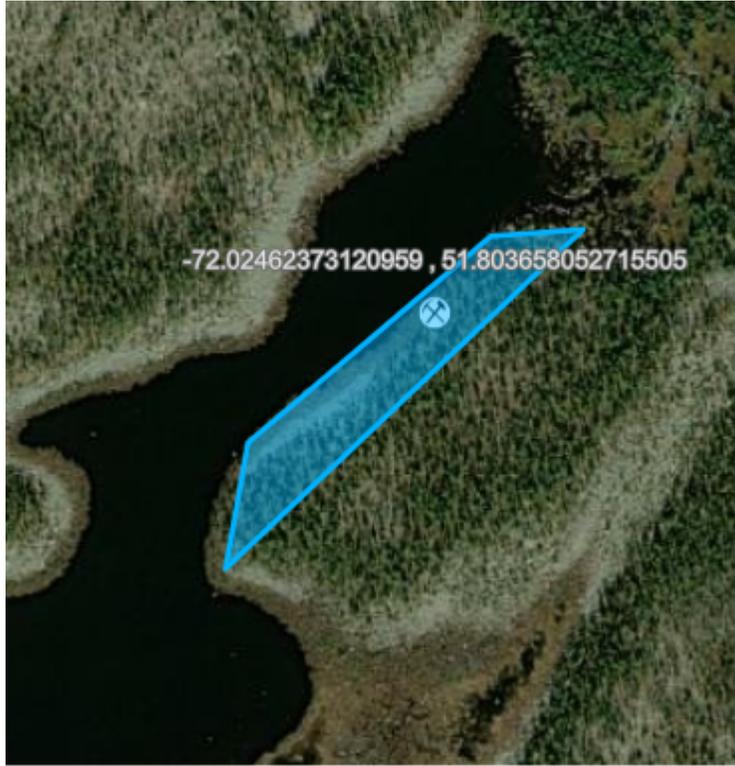
| Drums | | | | | |
|---|---|---|---|---|---|
| Nb total: 8 | | | | | |

| Other Information : 5 drums in one spot in fair condition. 3 other drums spread out along shore. | |
