**Objet : Demande d'accès à l'information**

## Site Characterization Report

| <div>Ministère des<br/>Ressources naturelles<br/>et des Forêts</div> <div>Québec</div> <div>Direction de la restauration des sites miniers</div> | <div>Fiche d'inspection<br/>des sites miniers</div> <div>Région 10 : Nord-du-Québec<br/>Coba : 8341-0591</div> | <div>ICON SULLIVAN</div> | <div>2023-08-29</div> |

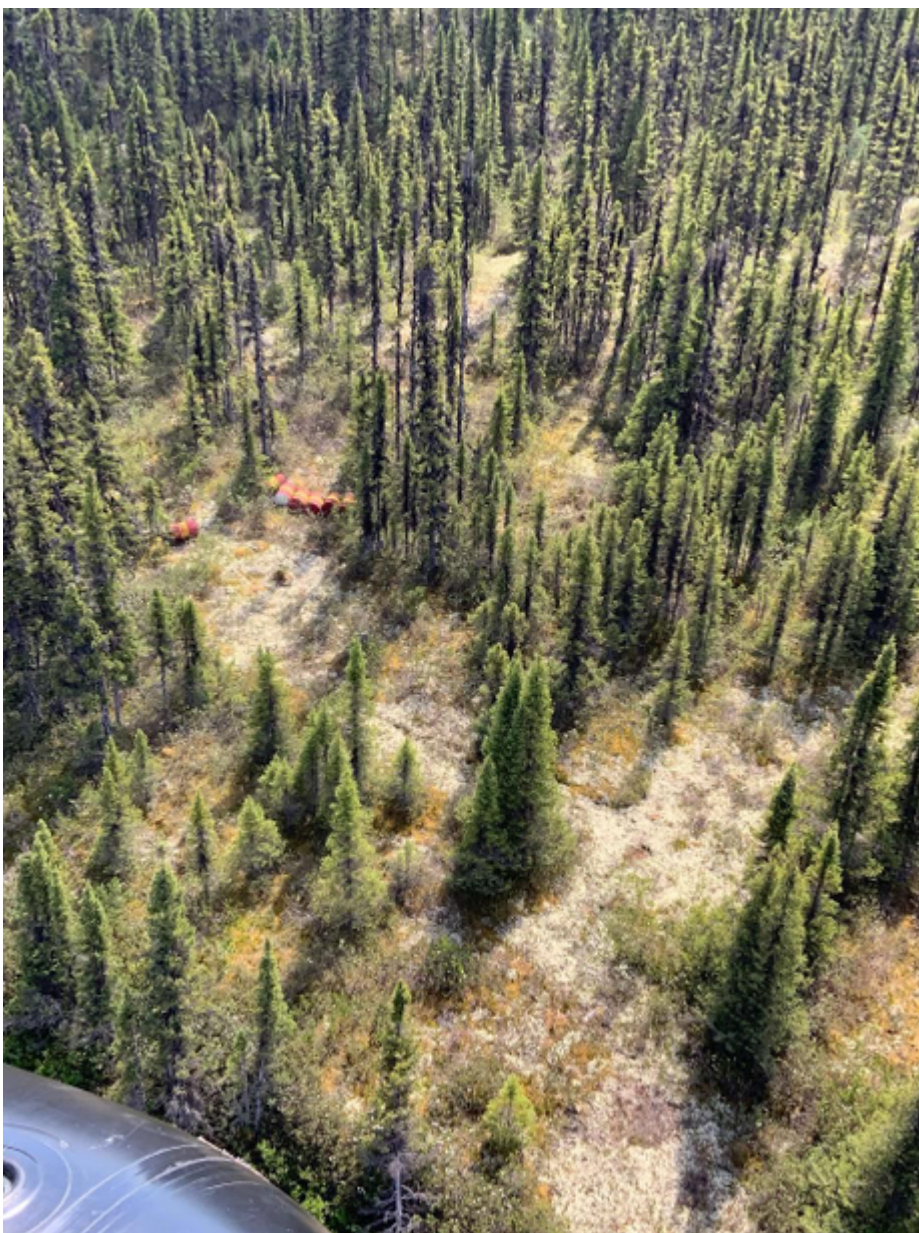
**Nb total:** 8

**Content:** Jet Fuel **Name of other:**

| Gas | Jet Fuel | Diesel | Oil | Grease | Other |
|---|---|---|---|---|---|
| Nb of full: | Nb of full:<br>8 | Nb of full: | Nb of full: | Nb of full: | Nb of full: |

**Distance from a sensitive area (m):** Less than 50 m

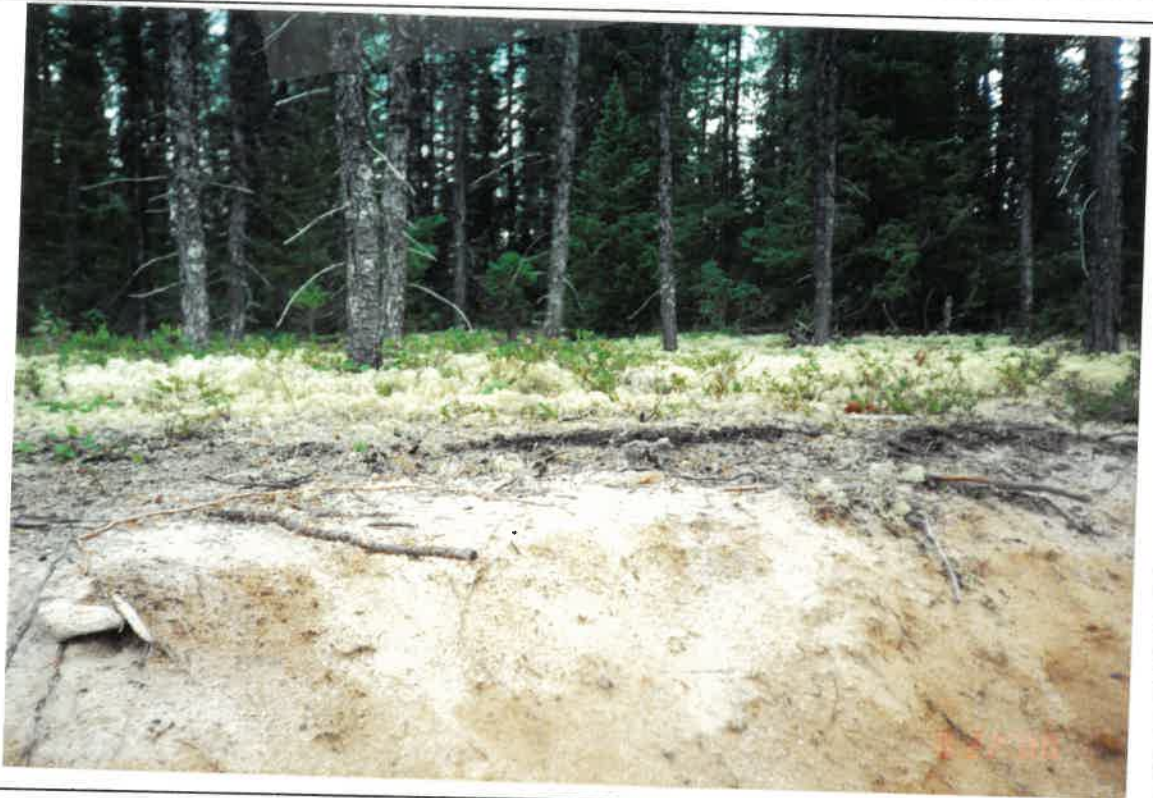
Photo 2

L'épaisseur de  
la terre végétale  
est très faible  
(env. 3 cm)

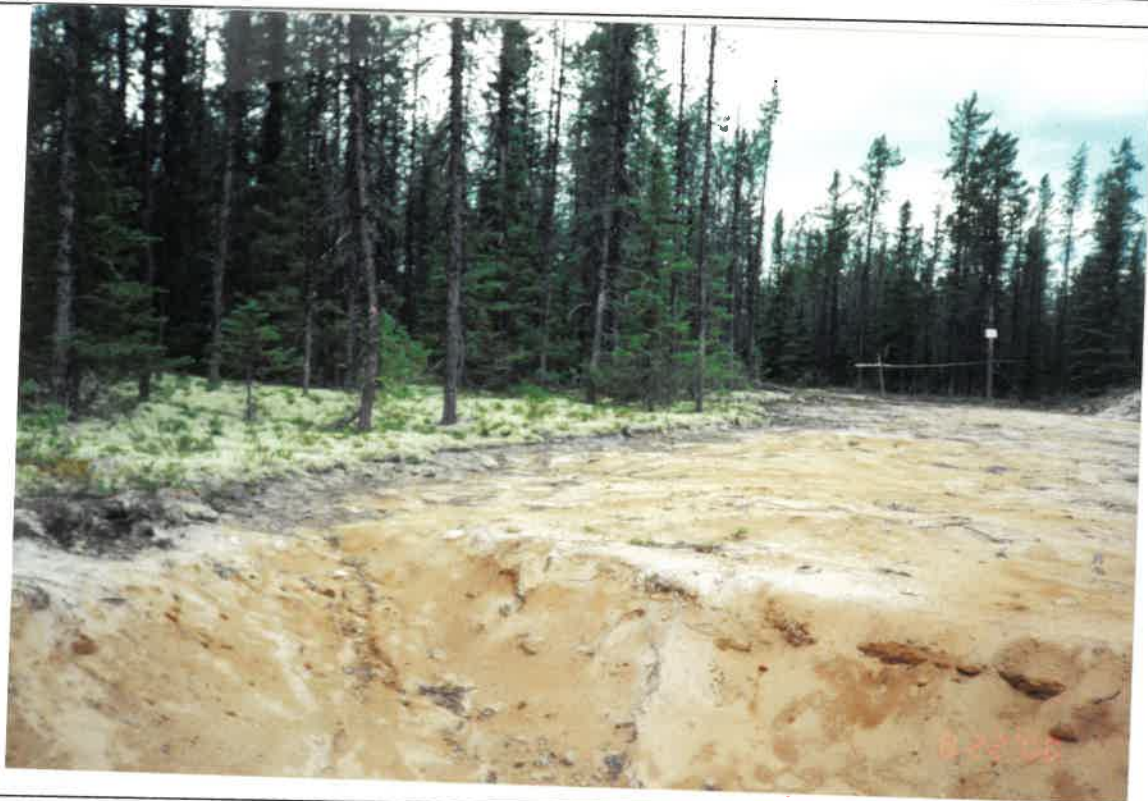
L'épaisseur de  
la terre végétale  
est constante  
dans toute la  
sablière

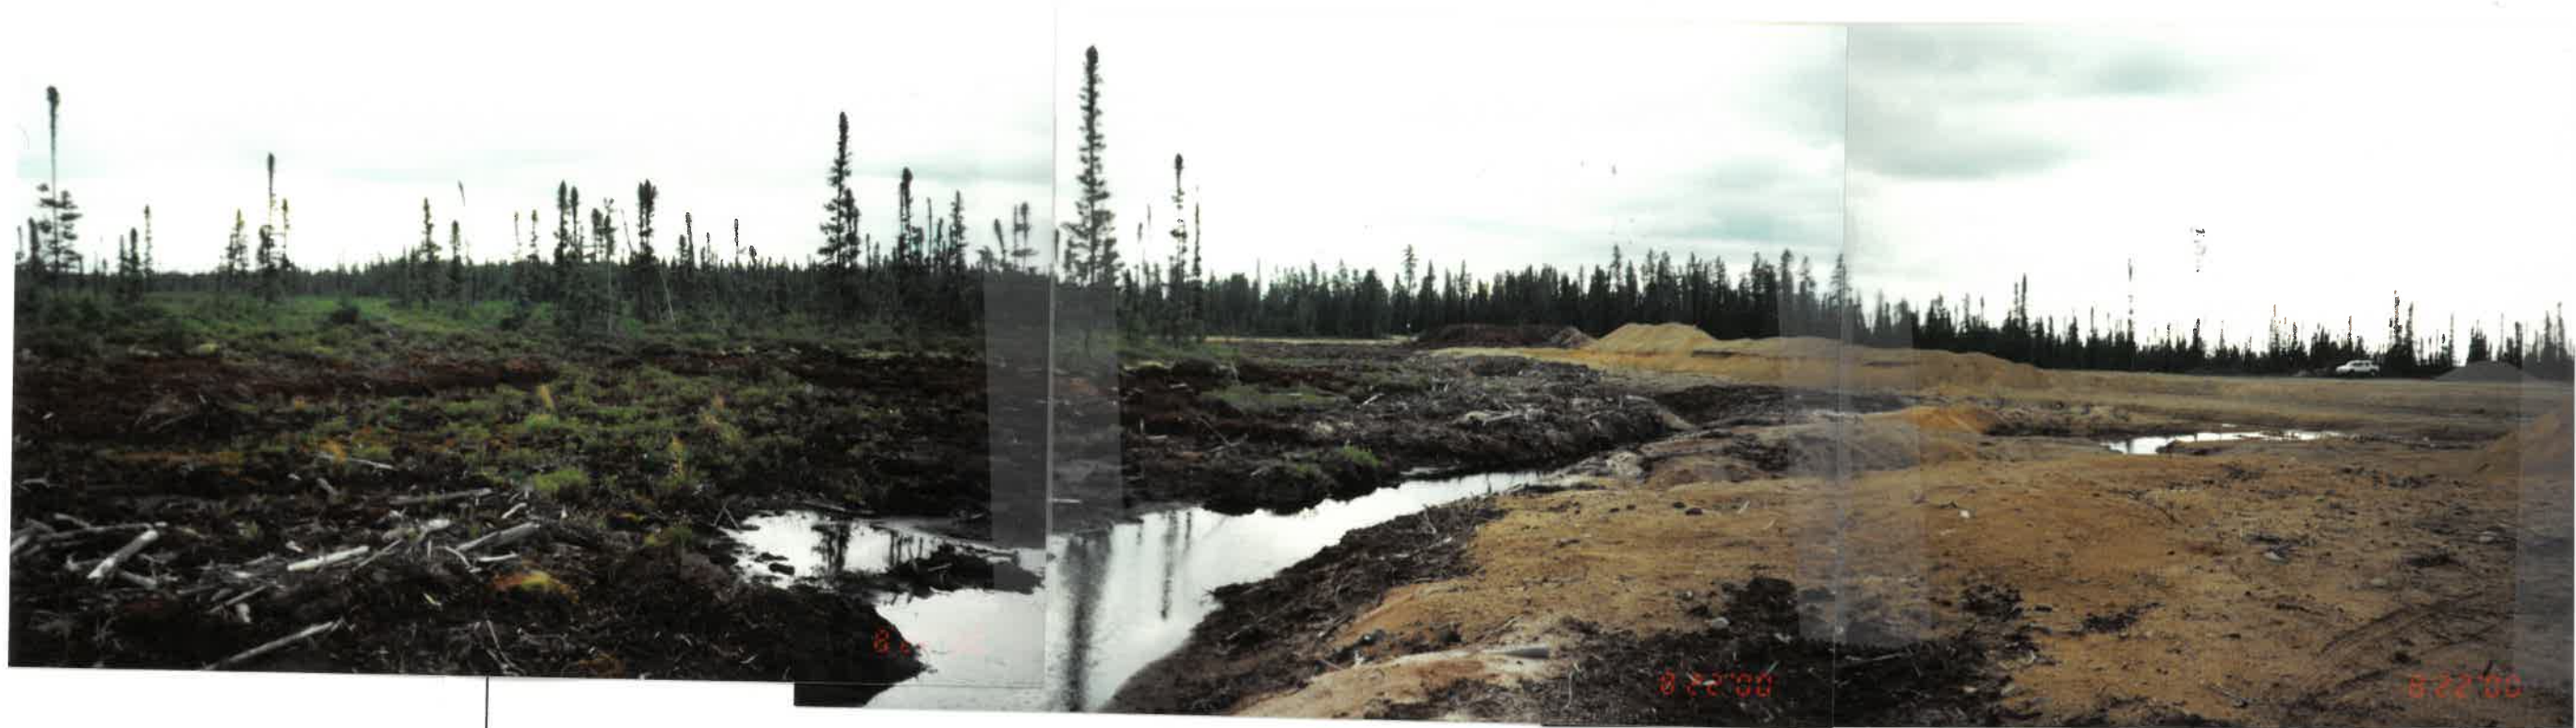
Secteur ou de la terre noire a été extraite (secteur sud-est)  
on regarde vers le sud.

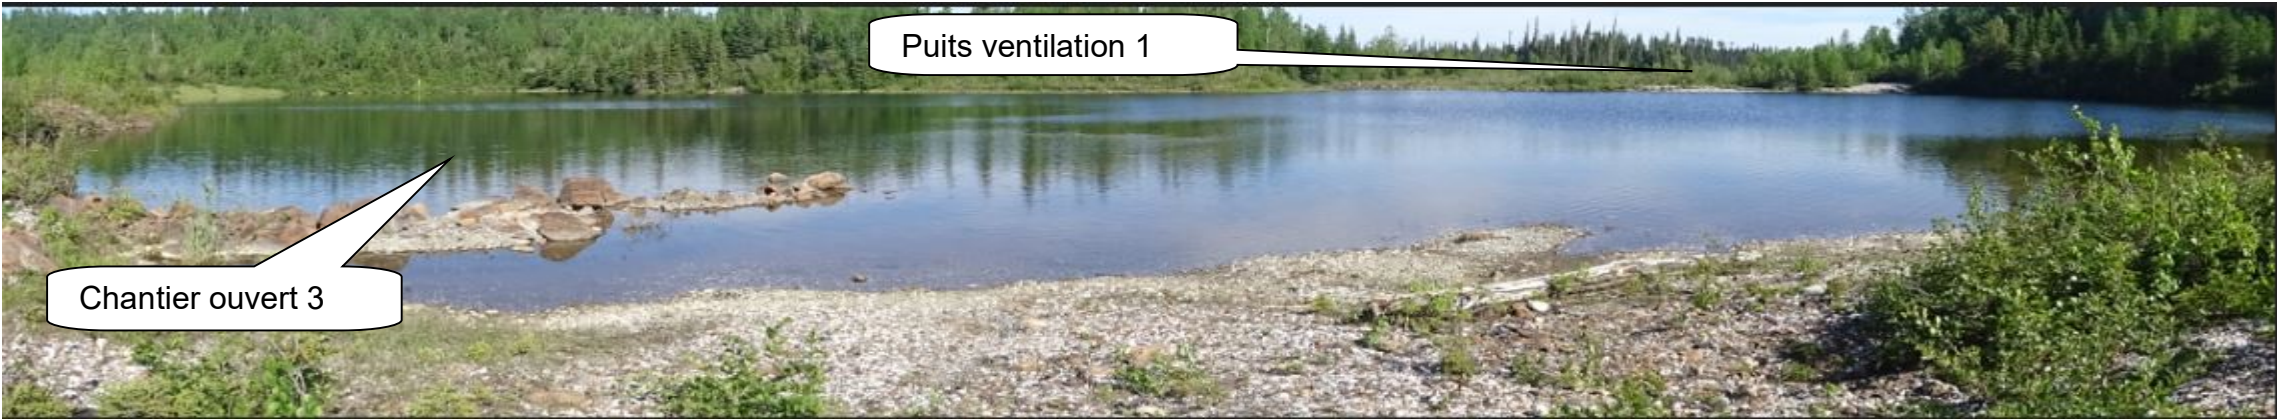
| Ouverture minière (puits, cheminée, fosse, chantier ouvert, rampe, galerie à flanc de coteau (adit), etc.) | | | | | |
|---|---|---|---|---|---|
| Sécurisation | Conforme ?<br>Aucune | Conforme ?<br>Aucune | Conforme ?<br>Aucune | Non Conforme<br>Clôture pour moutons | Conforme<br>Dalle de béton |

IS-2018-06-28-003 – Chantier ouvert 3 et le puits de ventilation 1 conforment (vue Ouest vers l'Est) Coordonnées UTM Nad83 : 584456 Est, 5566472 Nord

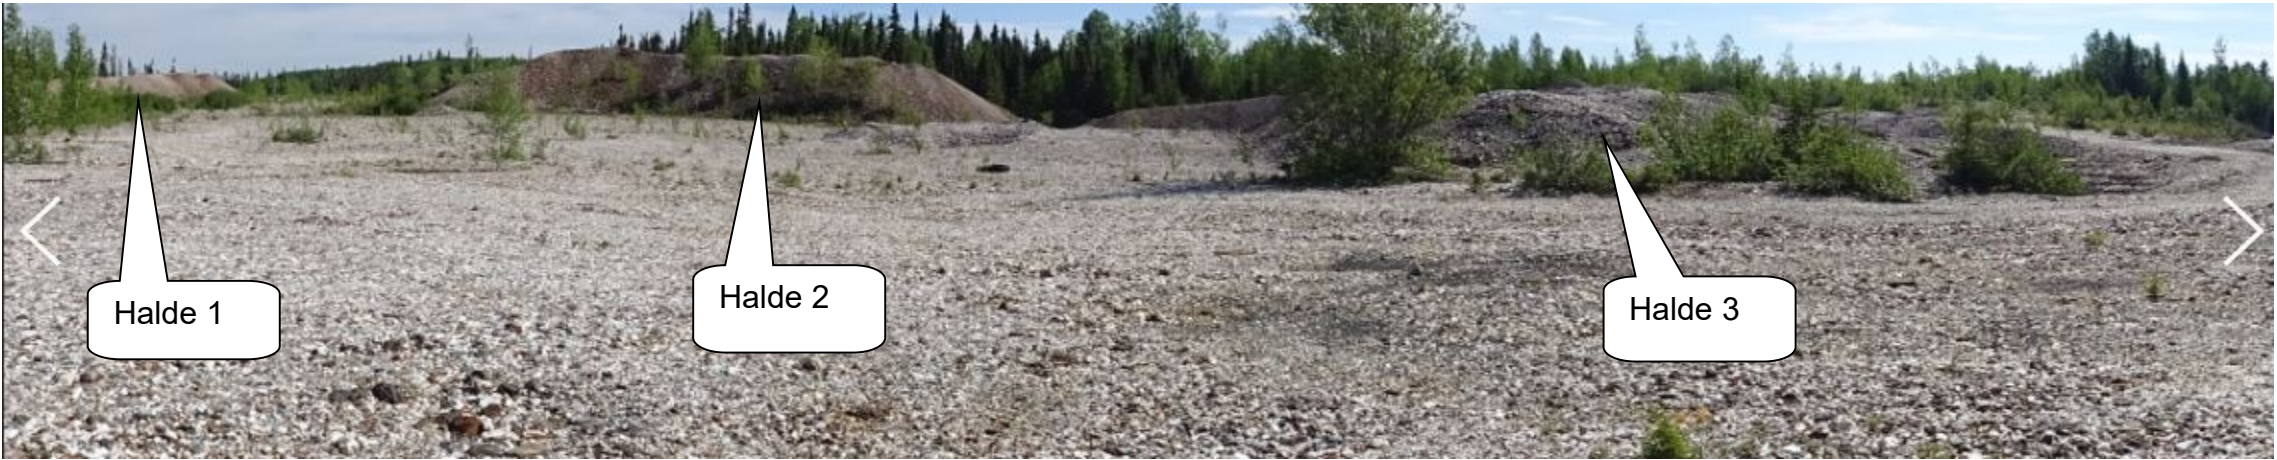
IS-2018-06-28-004 – Superficie A, avec les haldes à stériles 1,2 et 3 (vue du Nord vers le Sud) Coordonnées UTM Nad83 : 584581 Est, 5565762 Nord

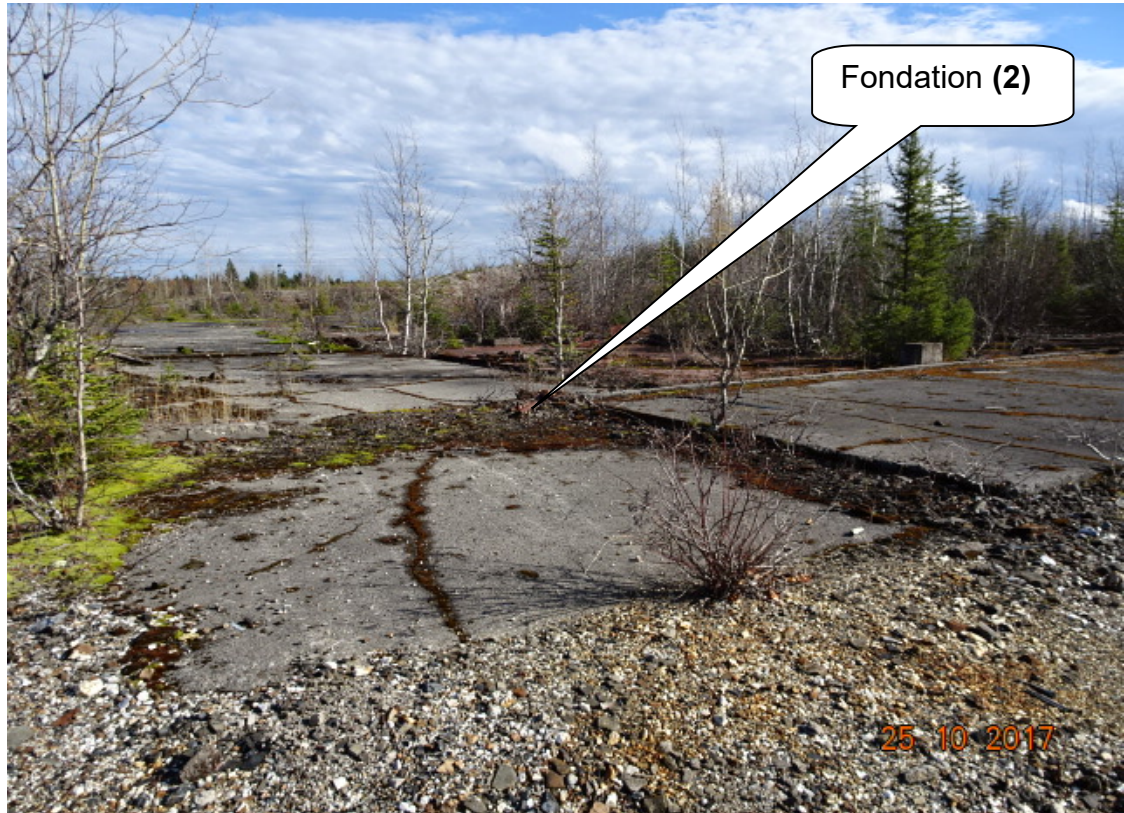
IS-2017-10-25-003 – Fondation de béton (2) (vue vers l'Est)

- Coordonnées : 584797 Est, 5565774 Nord \_\_\_\_\_ hauteur : 0,40 m.
- Photo : **IS-2017-10-25-003, IS-2020-06-04-008**
- Notes : à démolir et à enterrer \_\_\_\_\_ superficie : 1 654 m<sup>2</sup>.

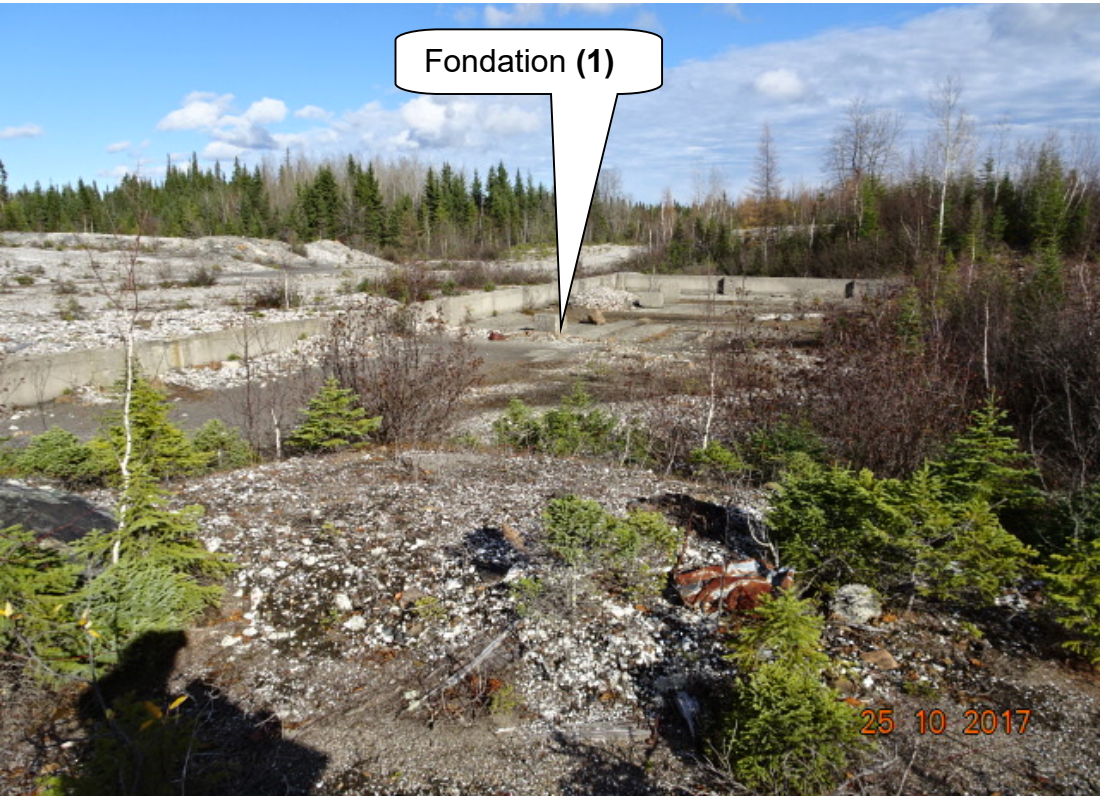
IS-2017-10-25-004 – Fondation de béton (1) (vue vers le Nord-Est)

- Coordonnées : 584842 Est, 5565851 Nord \_\_\_\_\_ hauteur : 0,65 mètre
- Photo : **IS-2017-10-25-004**
- Notes : à démolir et à enterrer \_\_\_\_\_ superficie : 521 m<sup>2</sup>.

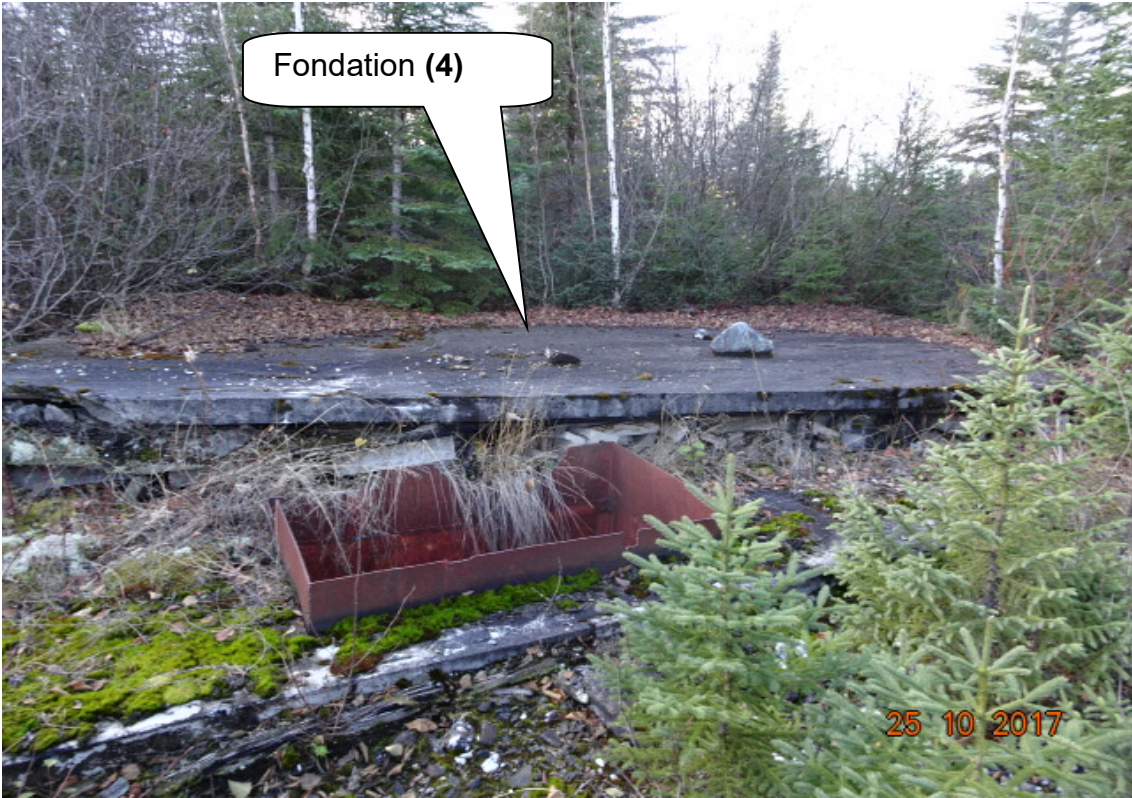
IS-2017-10-25-005 – Fondation de béton (4) (vue vers l'Ouest)

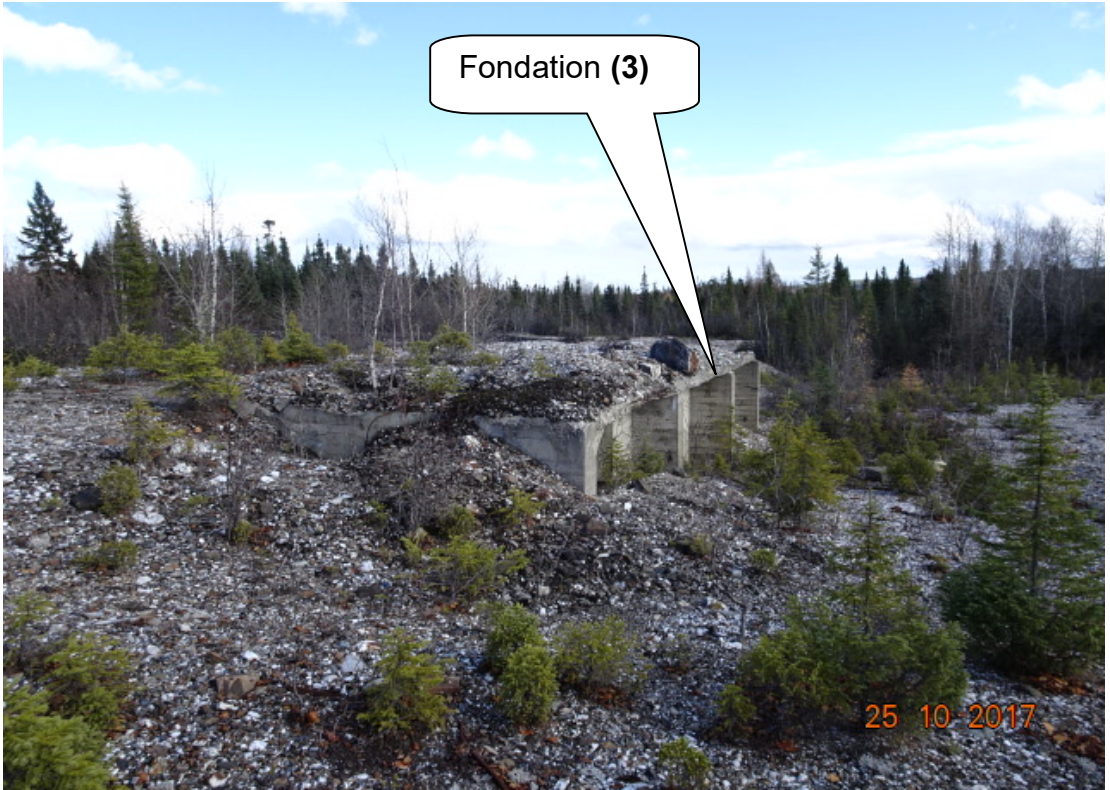
IS-2017-10-25-006 – Fondation de béton (3) (vue vers l'Est)

- Coordonnées : 584961 Est, 5565796 Nord \_\_\_\_\_ hauteur : 0,60 mètre
- Photo : **IS-2017-10-25-006**
- Notes : à démolir et à enterrer \_\_\_\_\_ superficie : 122 m<sup>2</sup>.

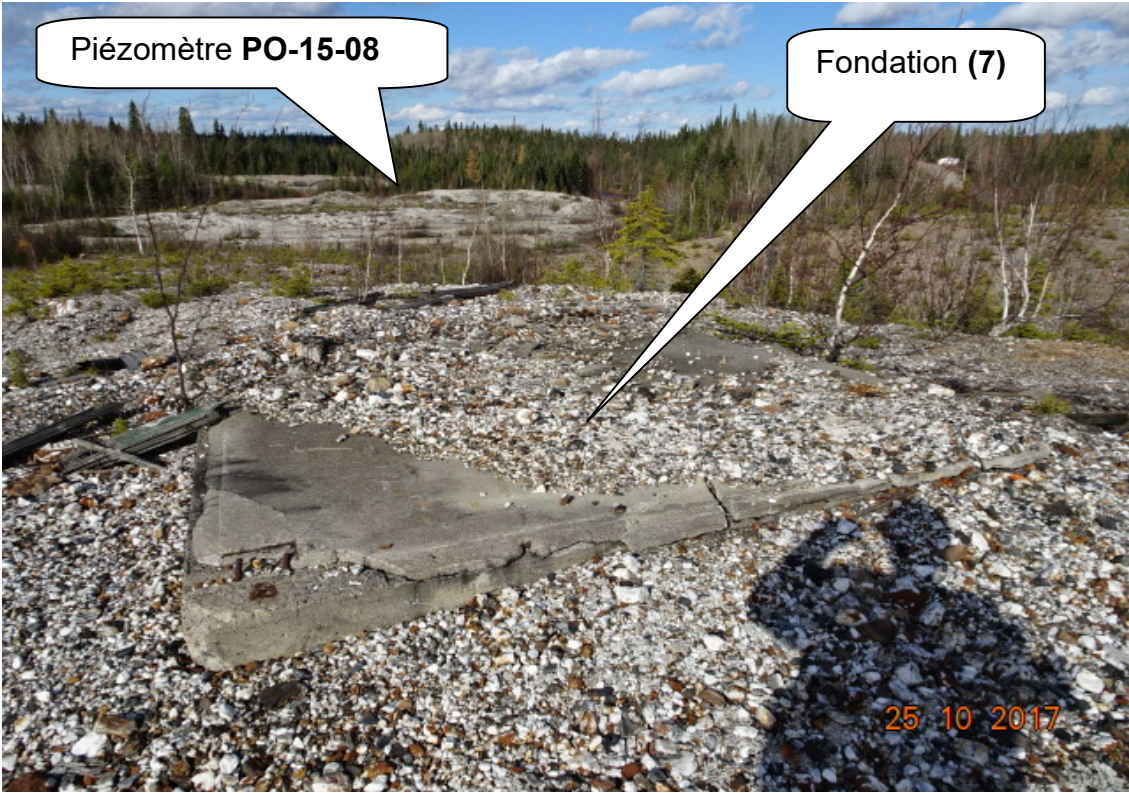
**IS-2017-10-25-007** – Fondation de béton (7) et arrière superficie B  
(vue vers le Nord)  
**Coordonnées UTM Nad83 : 584874 Est, 5565790 Nord**

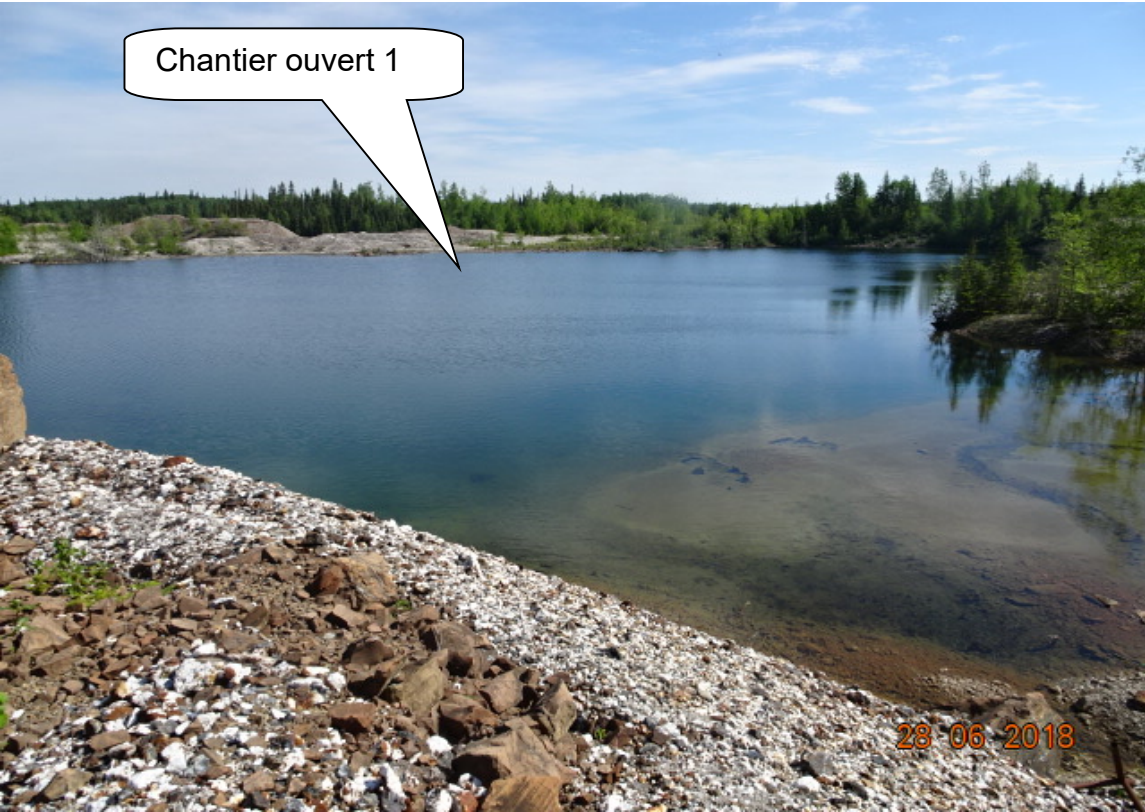
**IS-2018-06-28-005** – Du côté Sud-Ouest, vue du chantier ouvert 1  
(vue vers le Nord-Est)  
**Coordonnées UTM Nad83 : 584595 Est, 5565588 Nord**

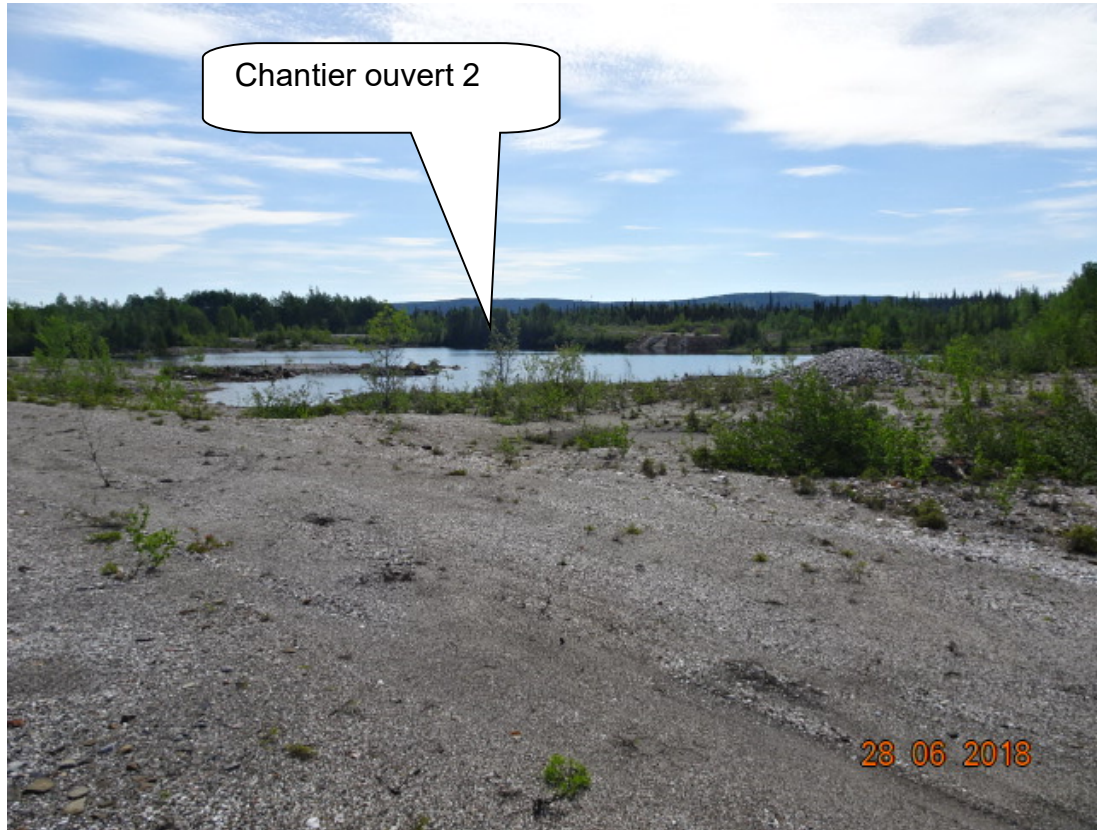
**IS-2018-06-28-008** – Du côté Nord-Ouest, vue du chantier ouvert 2  
(vue vers le Sud-Est)  
**Coordonnées UTM Nad83 : 584657 Est, 5565607 Nord**

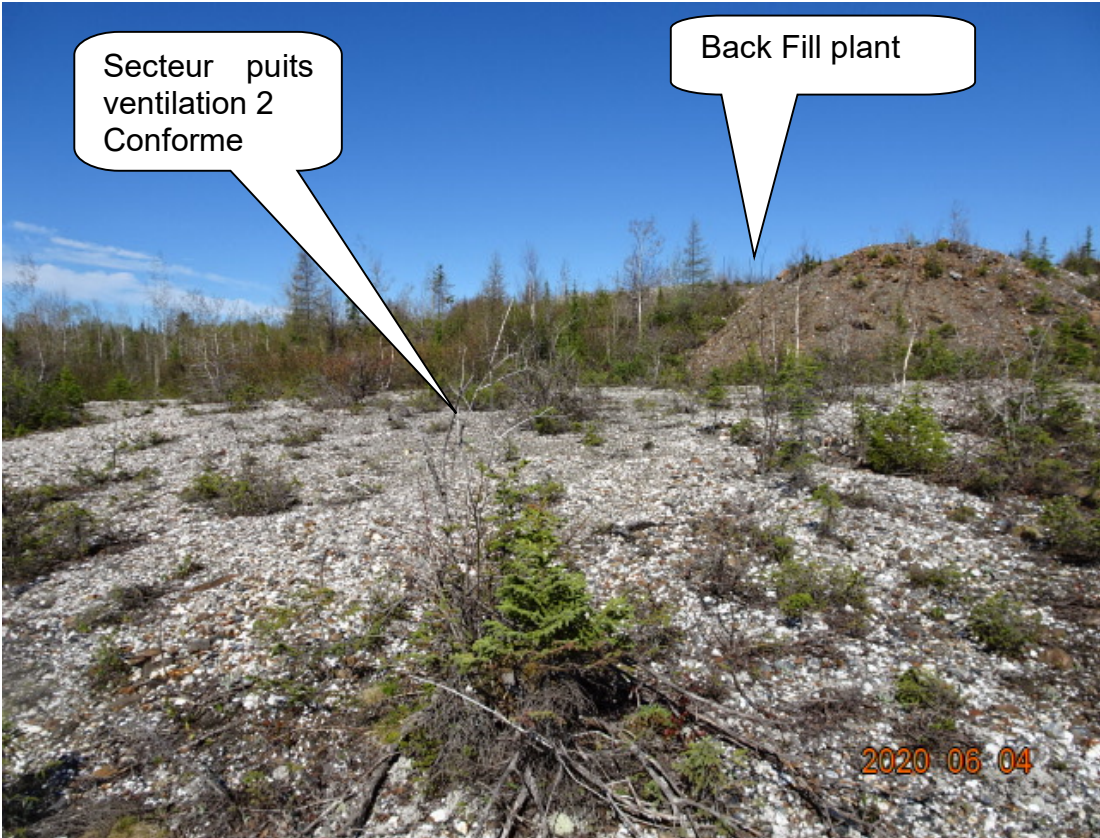
| Ouverture minière (puits, cheminée, fosse, chantier ouvert, rampe, galerie à flanc de coteau (adit), etc.) | | | | | |
|---|---|--|--|--|--|
| Sécurisation | Remblayé<br>Conforme | | | | |

**IS-2020-06-03-011** – Secteur du puits de ventilation 2, remblayé et situé à 100 m au Sud de Back Fill plant  
**Coordonnées UTM Nad83 : 584953 Est, 5565732 Nord**

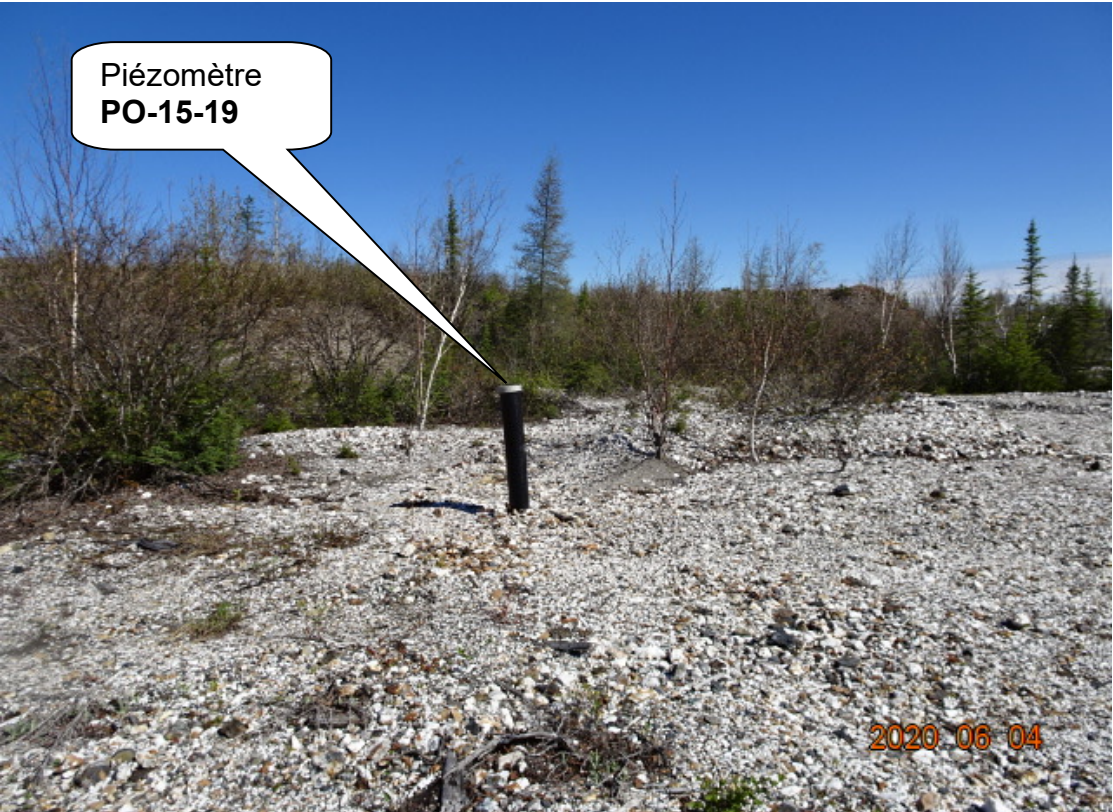
| Piézomètre | Coordonnées | | État | Situé | Remarques | Photos |
|---|---|---|---|---|---|---|
| PO-15-19 | 584908 | 5565695 | Très bon | W et 50m du puits ventilation 2 | | IS-2020-06-03-014 |

**IS-2020-06-03-014** – Piézomètre **PO-15-19**, situé à 50m à l'Ouest du puits  
ventilation 2 (vue vers le Nord)  
**Coordonnées UTM Nad83 : 584911 Est, 5565689 Nord**

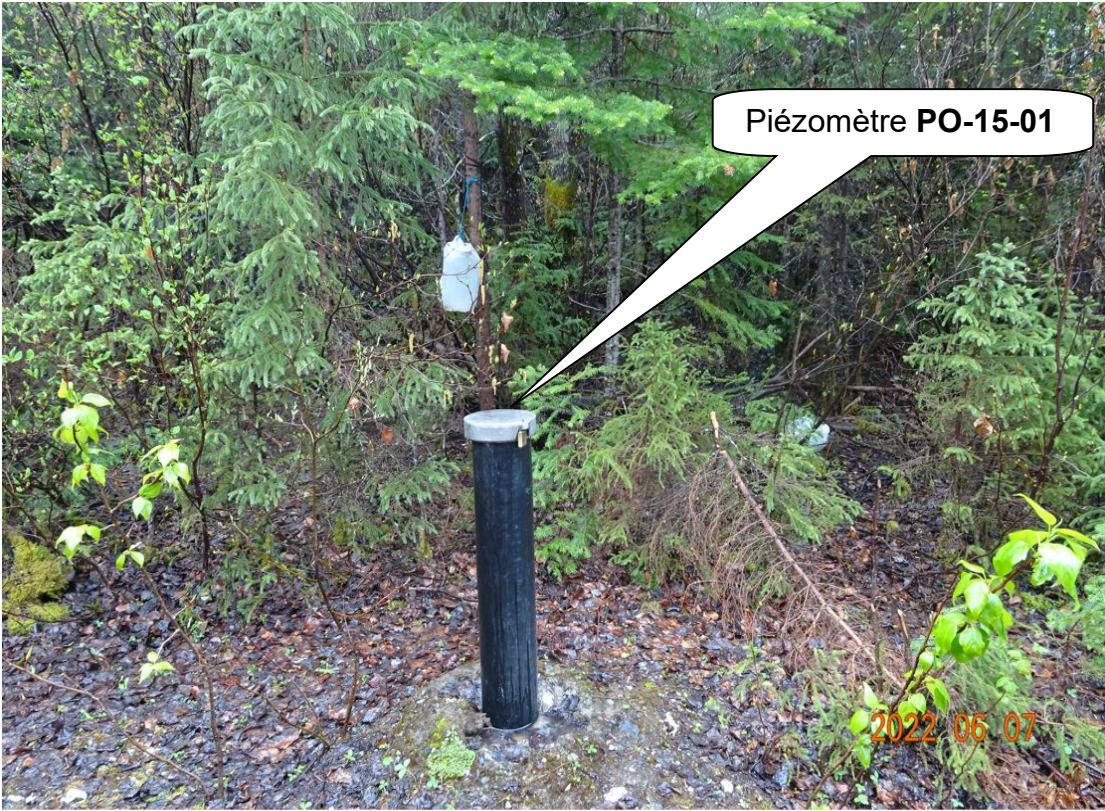
**IS-2022-06-07-004** - Piézomètre **PO-15-01** en très bon état  
(vue vers le Sud-Ouest)  
Coordonnées UTM Nad83 : 585340 Est, 5566344 Nord

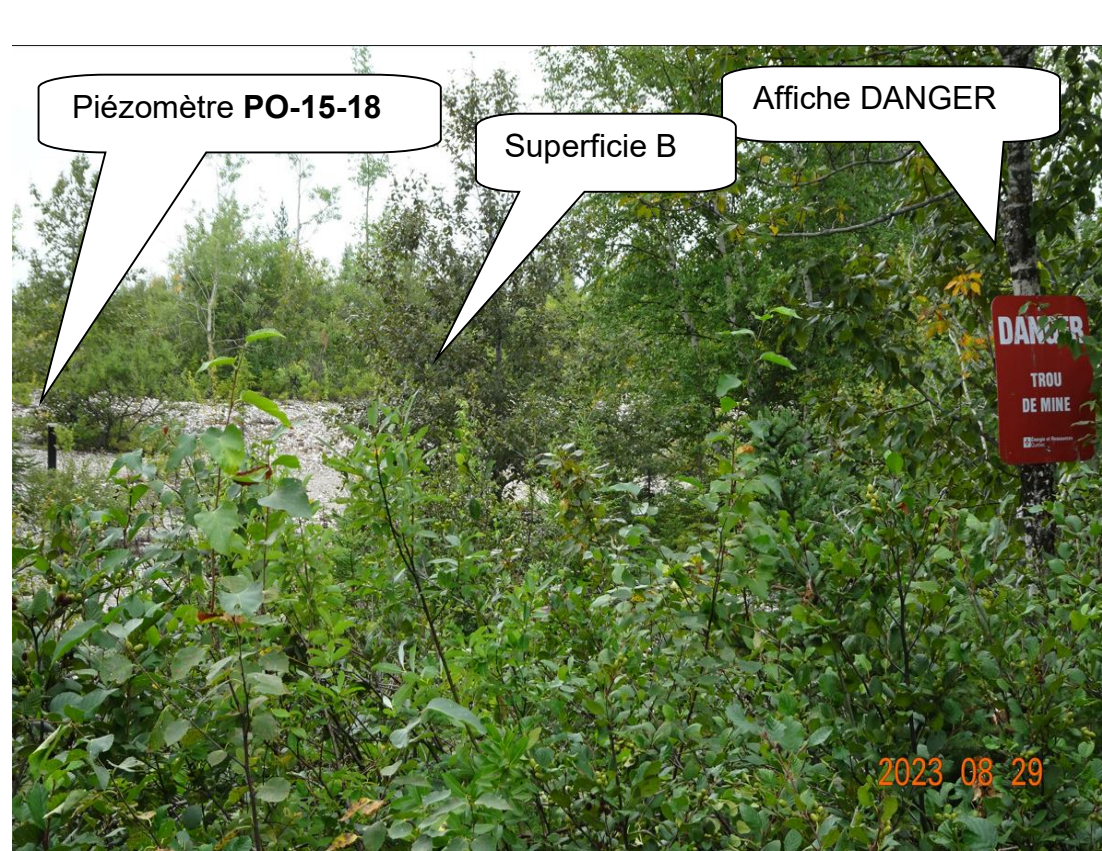
| Piézomètre | Coordonnées | | État | Situé | Remarques | Photos |
|---|---|---|---|---|---|---|
| PO-15-18 | 584916 | 5565903 | Très bon | N de la superficie B (ancien pont) | | IS-2023-08-29-002 |

**IS-2023-08-29-002** – Affiche Danger situé à l'ancien pont enlevé. En arrière le piézomètre **PO-15-18** (vue vers le Sud-Ouest)  
**Coordonnées UTM Nad83 : 584918 Est, 5565944 Nord**

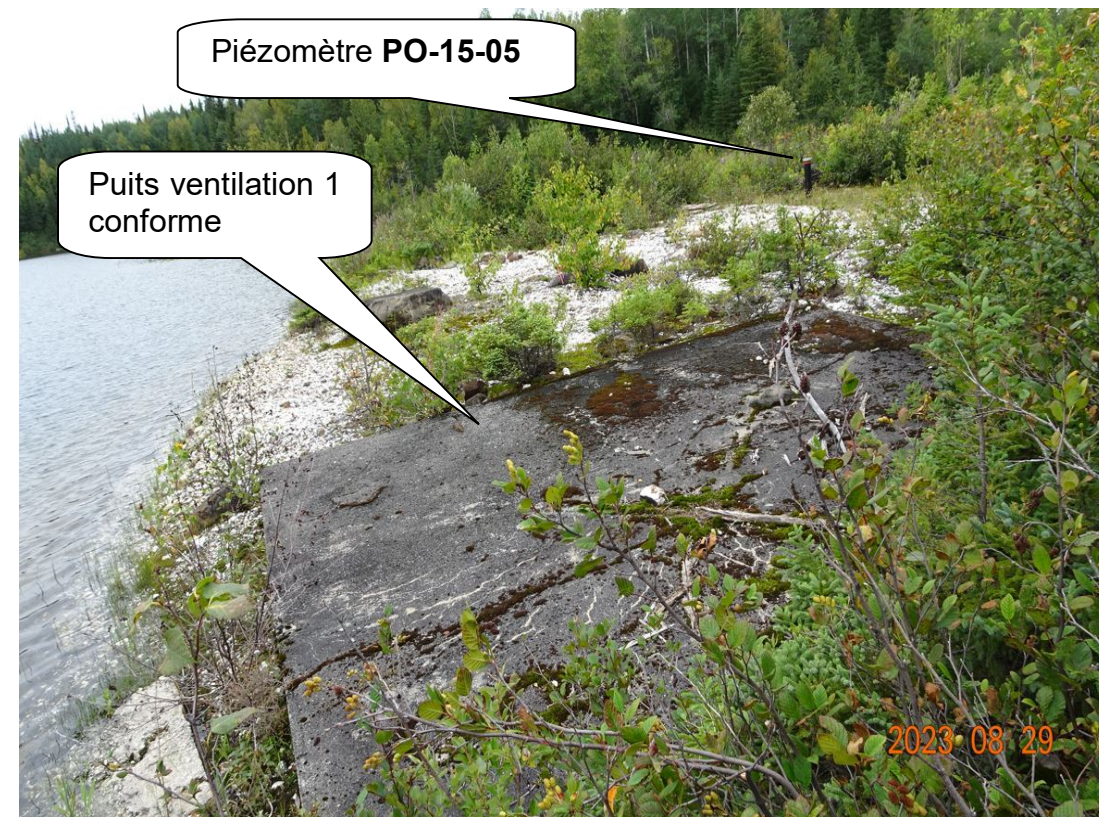
**IS-2023-08-29-003** – Puits de ventilation 1 conforme et piézomètre **PO-15-05** (vue vers l'Est)  
**Coordonnées UTM Nad83 : 584462 Est, 5566588 Nord**

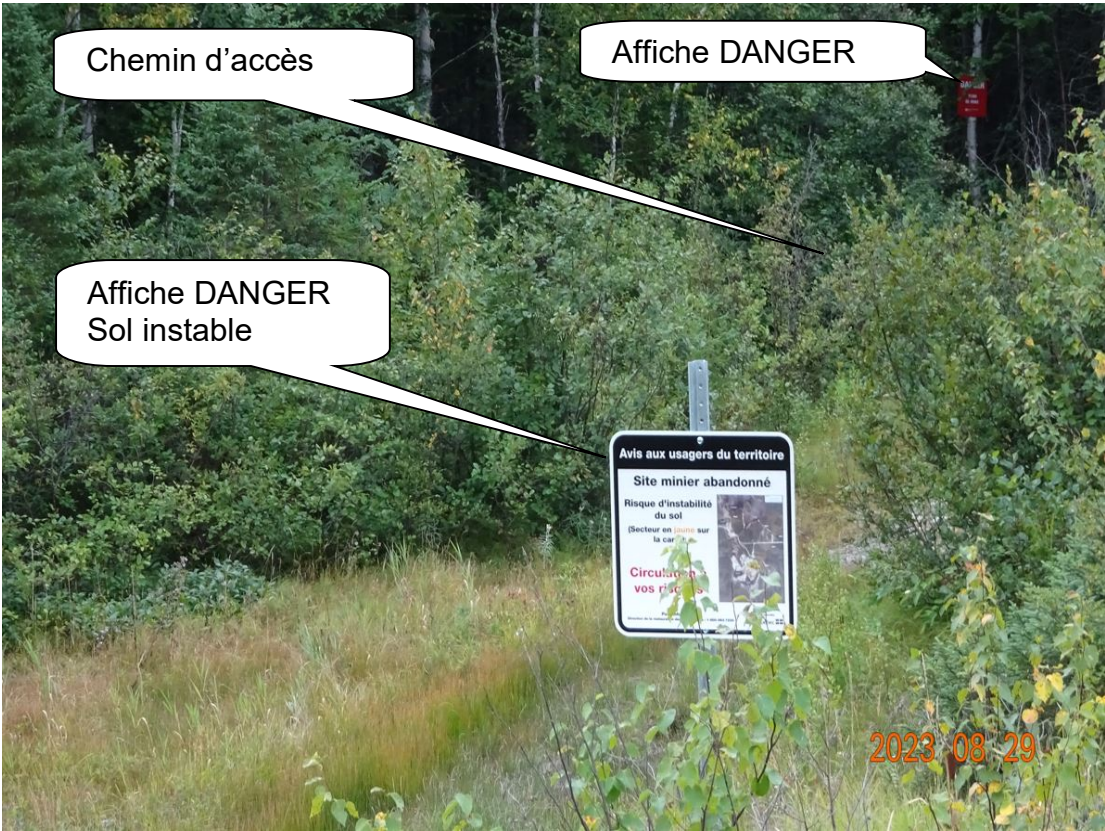
**IS-2023-08-29-004** – 2 affiches Danger situé au chemin d'accès  
(vue vers le Sud-Ouest)  
**Coordonnées UTM Nad83 : 584512 Est, 5566267 Nord**
